November 2019 Quarterly Environmental Monitoring – Dunmore Recycling and Waste Disposal Depot, Dunmore, New South Wales.

1 Introduction

Environmental monitoring is undertaken on a quarterly basis at the Dunmore Recycling Waste Disposal Depot, Dunmore, NSW (the site), in accordance with Environment Protection Licence (EPL) No. 5984, refer to Figure 1 (**Appendix A**). The monitoring includes sampling groundwater bores, a leachate pond, surface water bodies, a dust gauge and landfill gas at the landfill surface to detect any potential impacts of land filling activities on the environment.

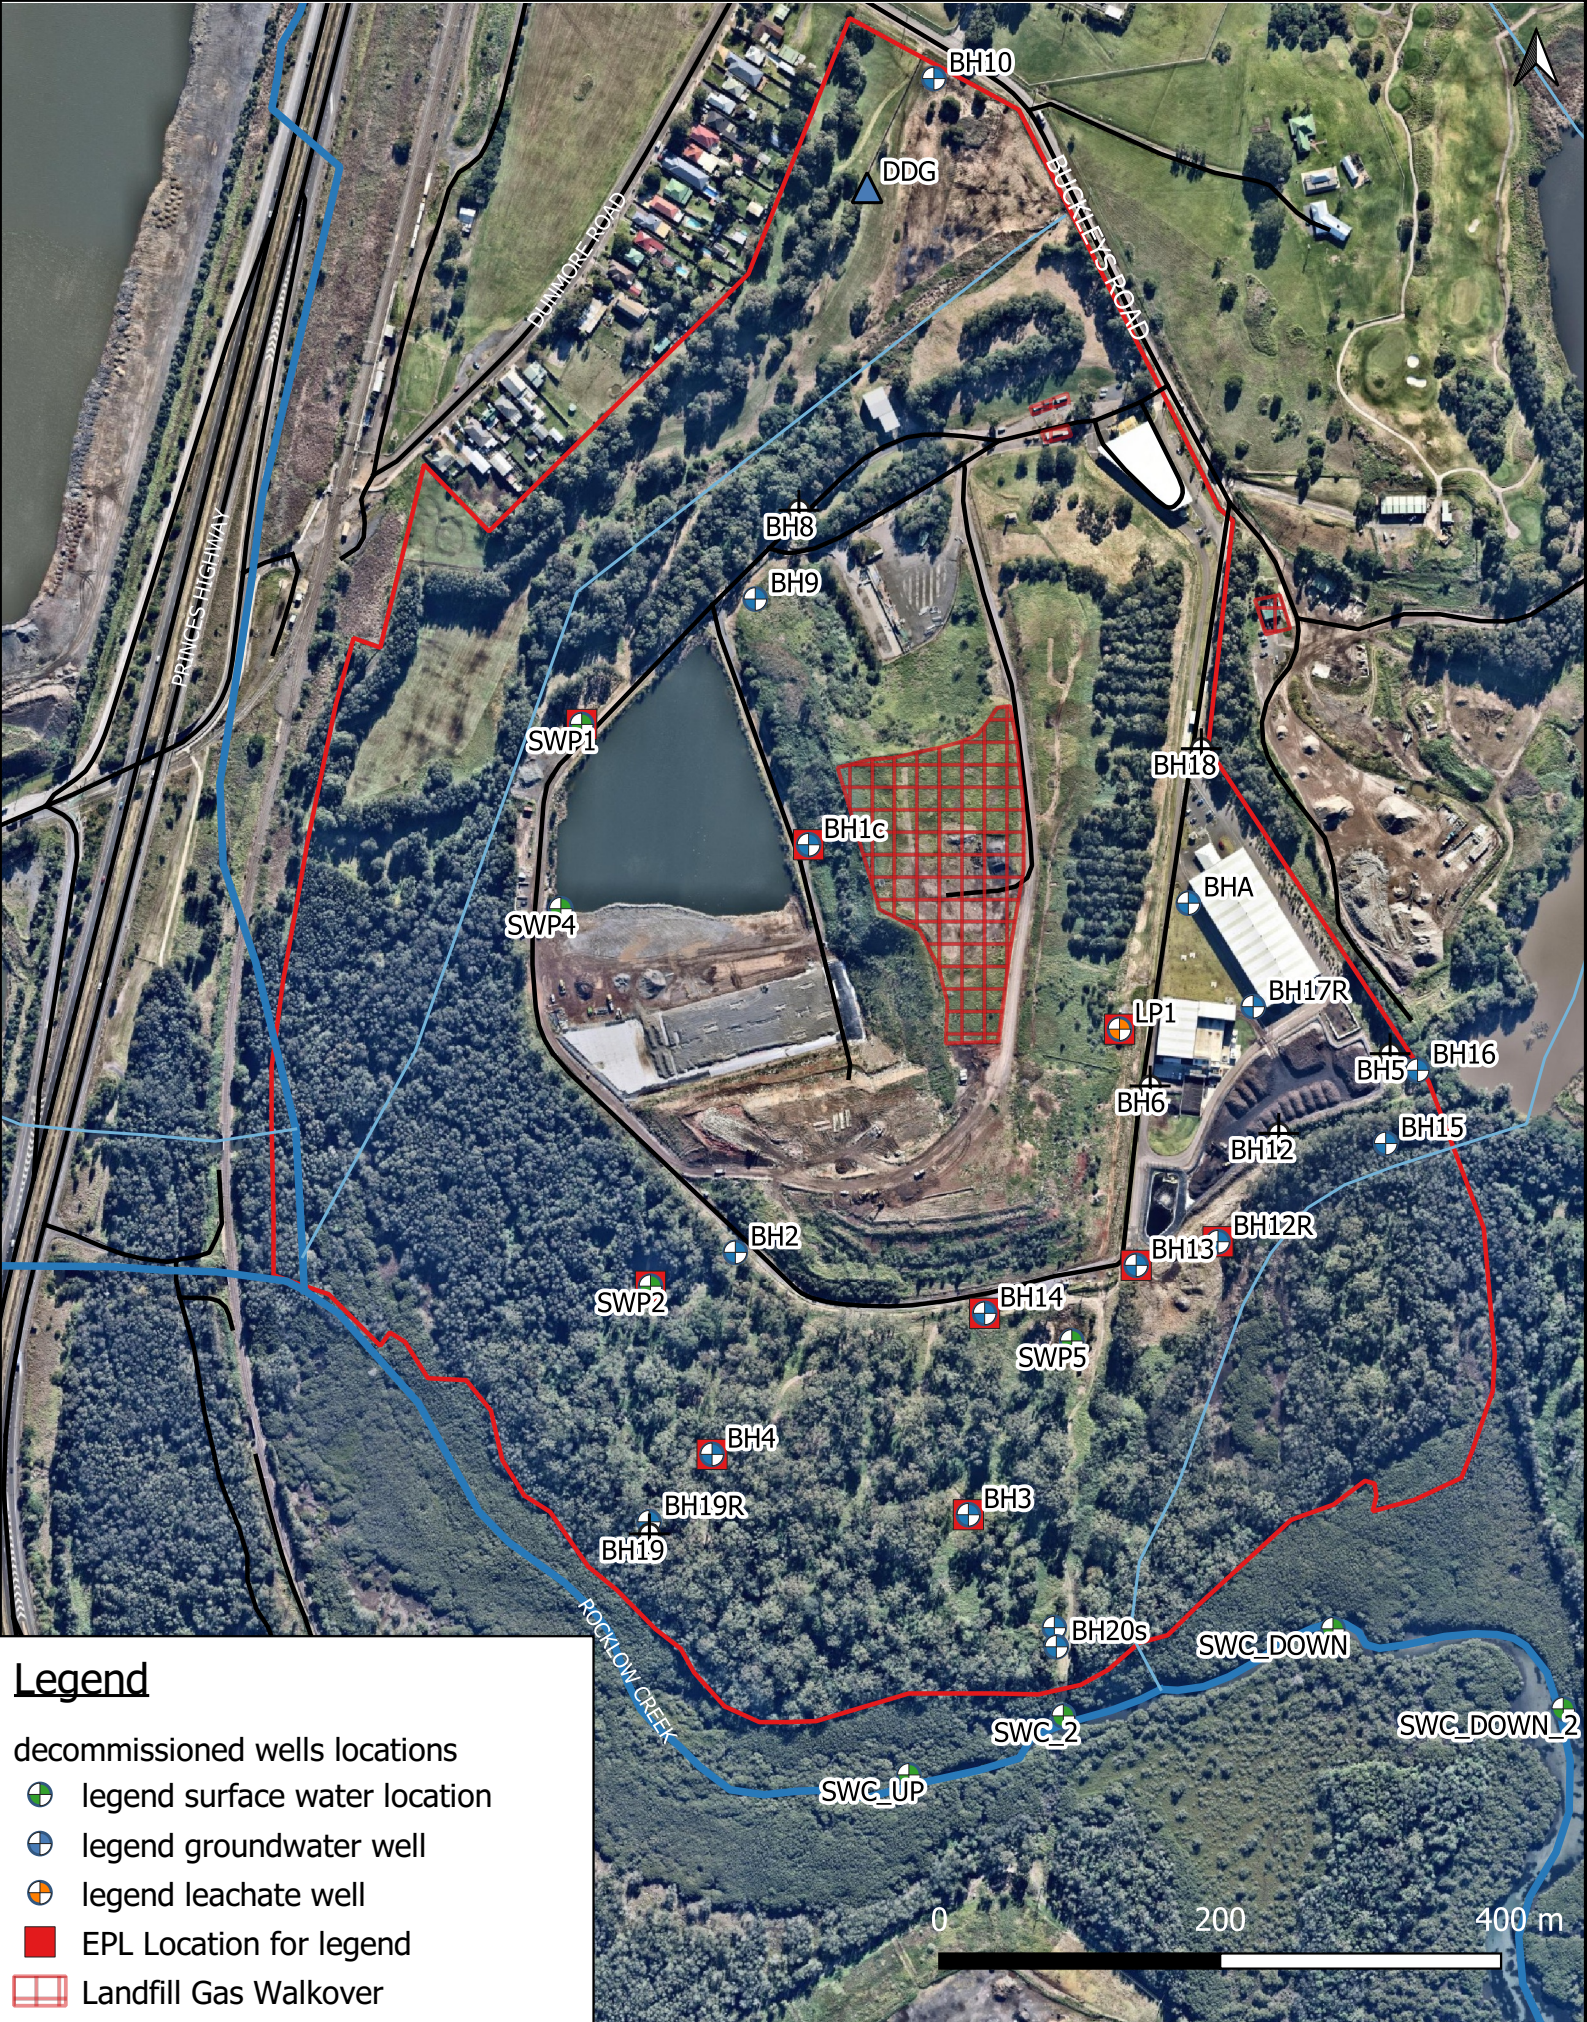
ENVIRONMENTAL EARTH SCIENCES <small>CONTAMINATION RESOLVED</small>	Drawn by: MN	Date: Nov 2019	Dunmore Resource and Recycling	Figure No.
	Proj. Manager: EG	Scale: As shown		
	Job No: 118109	Source: Google	Shellharbour, NSW	1

A dust gauge bottle was collected to the north of the site (DDG) and a gas walkover of all site buildings and the landfill cap was also undertaken. Landfill gas was measured in the field using a Flame Ionisation Detector (FID) and a GA5000 Landfill Gas Analyser (GS5000). Sampling locations are shown on Figure 2 (**Appendix A**).

Water quality sampling was undertaken at the locations illustrated in Figure 2 (**Appendix B**) except for SWP5 and BH14 which were dry.

Measurements were taken within and around all buildings in a 250 m radius from the current landfill cell as well as across the landfill cap (gas walkover grids of the November 2019 round are indicated in Figure 2, **Appendix A**). Weather conditions observed during gas monitoring on 19 November 2019, based on readings from the weather station at Albion Park¹ are summarised in **Table 2**.

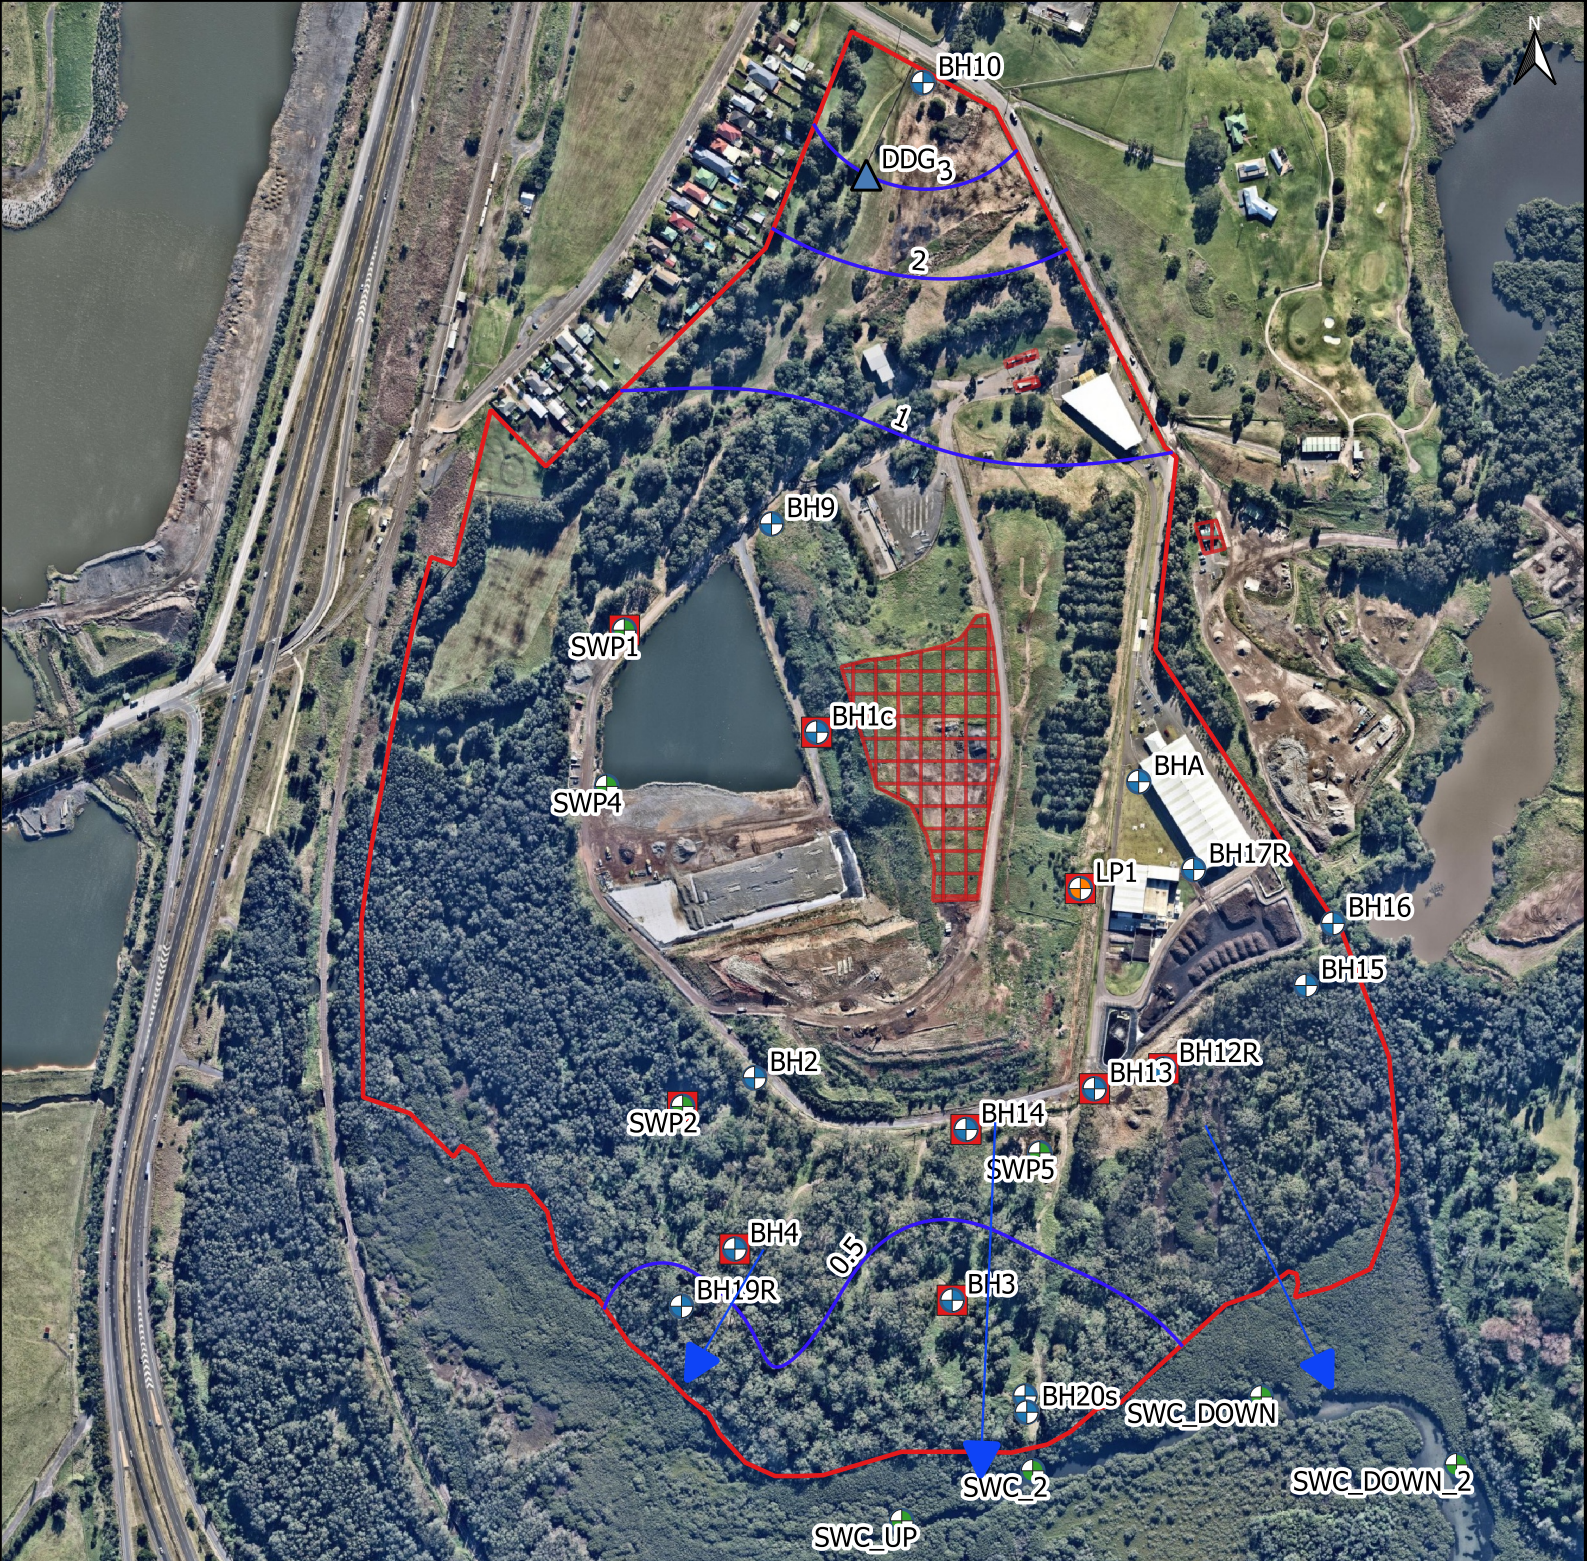
Inferred groundwater flow patterns based on the November 2019 standing water level (SWL) measurements were calculated using SWLs from surveyed bores and are an indicative representation of the groundwater flow patterns onsite. Similar to previous monitoring, groundwater flow was towards Rocklow Creek in a southerly direction, refer to Figure 3 (**Appendix A**).

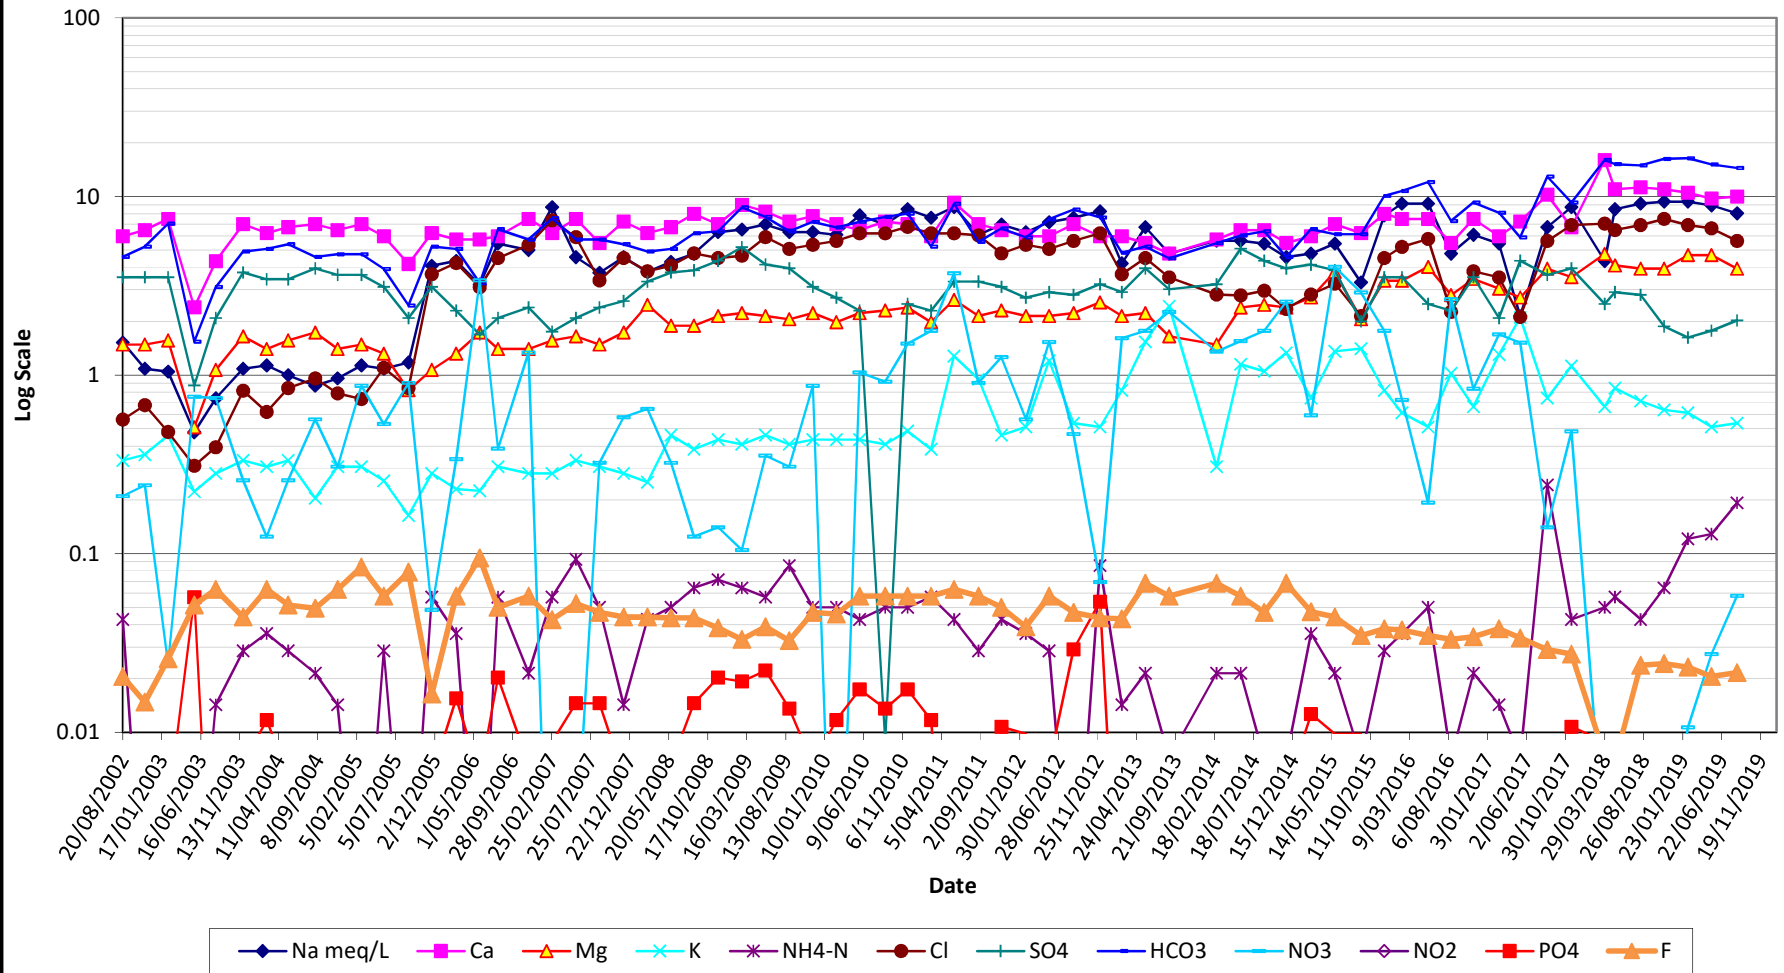
Bore BH15 has displayed a decreasing L/N ratio trend since November 2017, where the L/N ratio was 109.33%. L/N ratio in November 2019 of 70.3% has doubled since the November 2018 monitoring round. The K^+/TDS ratio of 14.54 % was high when compared to non-leachate influenced sites generally with $\text{K}^+/\text{TDS} < 3$ (Table 6, **Appendix B** and Schoeller plot BH15, **Appendix C**). Ammonium ($\text{NH}_4^{+}\text{-N}$) remains elevated at 89 mg/L, compared to other non-impacted locations at the site, which is consistent with previous monitoring rounds. Field measurements of a negative redox (negative ORP) and low dissolved oxygen are indicative of a reducing environment. Elevated levels of soluble Fe^{2+} (14 mg/L) is an indicator of a reducing environment that is favourable for the degradation of leachate. BH15 is located within a swampy environment where microbiological activity drives reducing reactions that can result in naturally high levels of leachate indicators such as organic carbon and HCO_3^- . However, as L/N ratio has decreased, these indicators have also decreased. It is important to note that bore BH15 is located near a drainage line within the groundwater bearing zone <0.5 m below the ground surface. Groundwater therefore has the potential to be influenced from local onsite and offsite works and surface water.

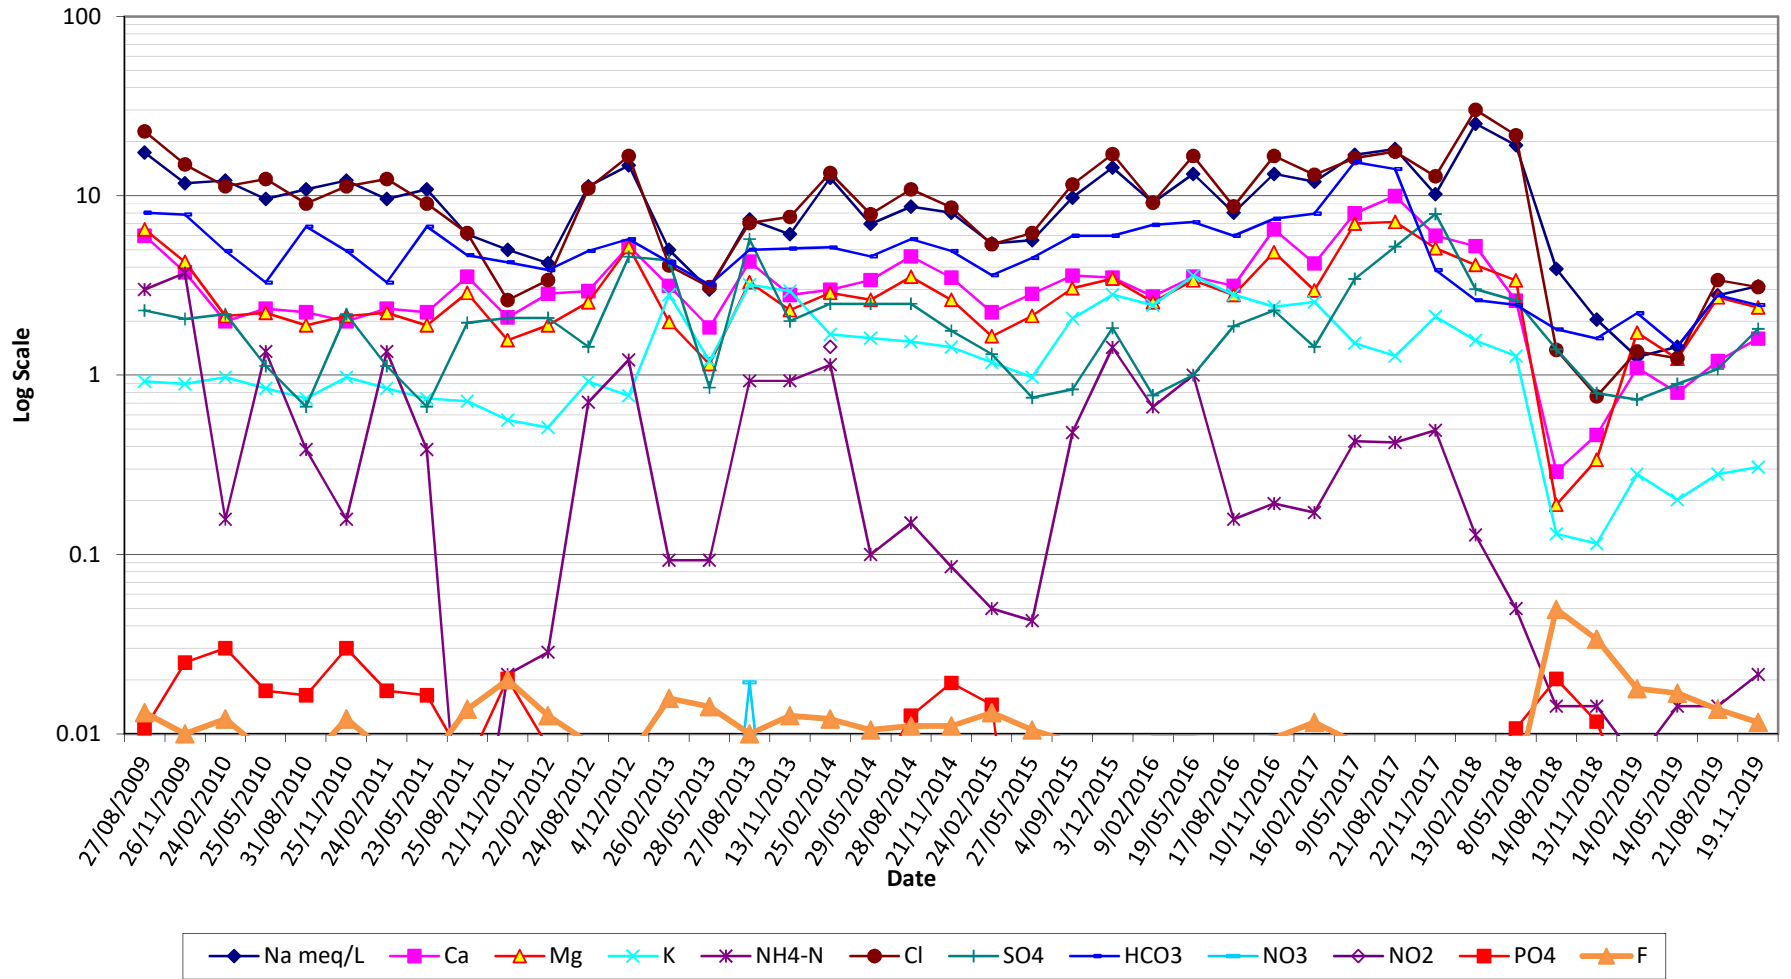
BH17-R

BH17R was installed in July 2019 to replace BH17b, following the development of the new facilities at Dunmore Resource & Recycling. Bore 17R is located to the east of the leachate tanks, which provides coverage to the eastern bounds of the site (Figure 1). Results compared with historical data from BH17 (Schoeller plot BH17, **Appendix C**) indicates that the chemical signature has reduced slightly since 2016 but remains broadly stable. The L/N ratio (19.64 %) (Table 6, **Appendix B**) is lower than the August 2019 monitoring round, but still higher than the last recorded value of nearby bore BH17 (7.06%). However, is consistent with values recorded in 2012. Negative ORP (-144 mV) and very low dissolved oxygen (1 ppm) in addition to elevated concentrations of Fe (2.6 mg/L) are indicative of an anaerobic environment and high microbial activity.
