May 2018 Quarterly Environmental Monitoring – Dunmore Recycling and Waste Disposal Depot, Dunmore, New South Wales.

1.0 Introduction

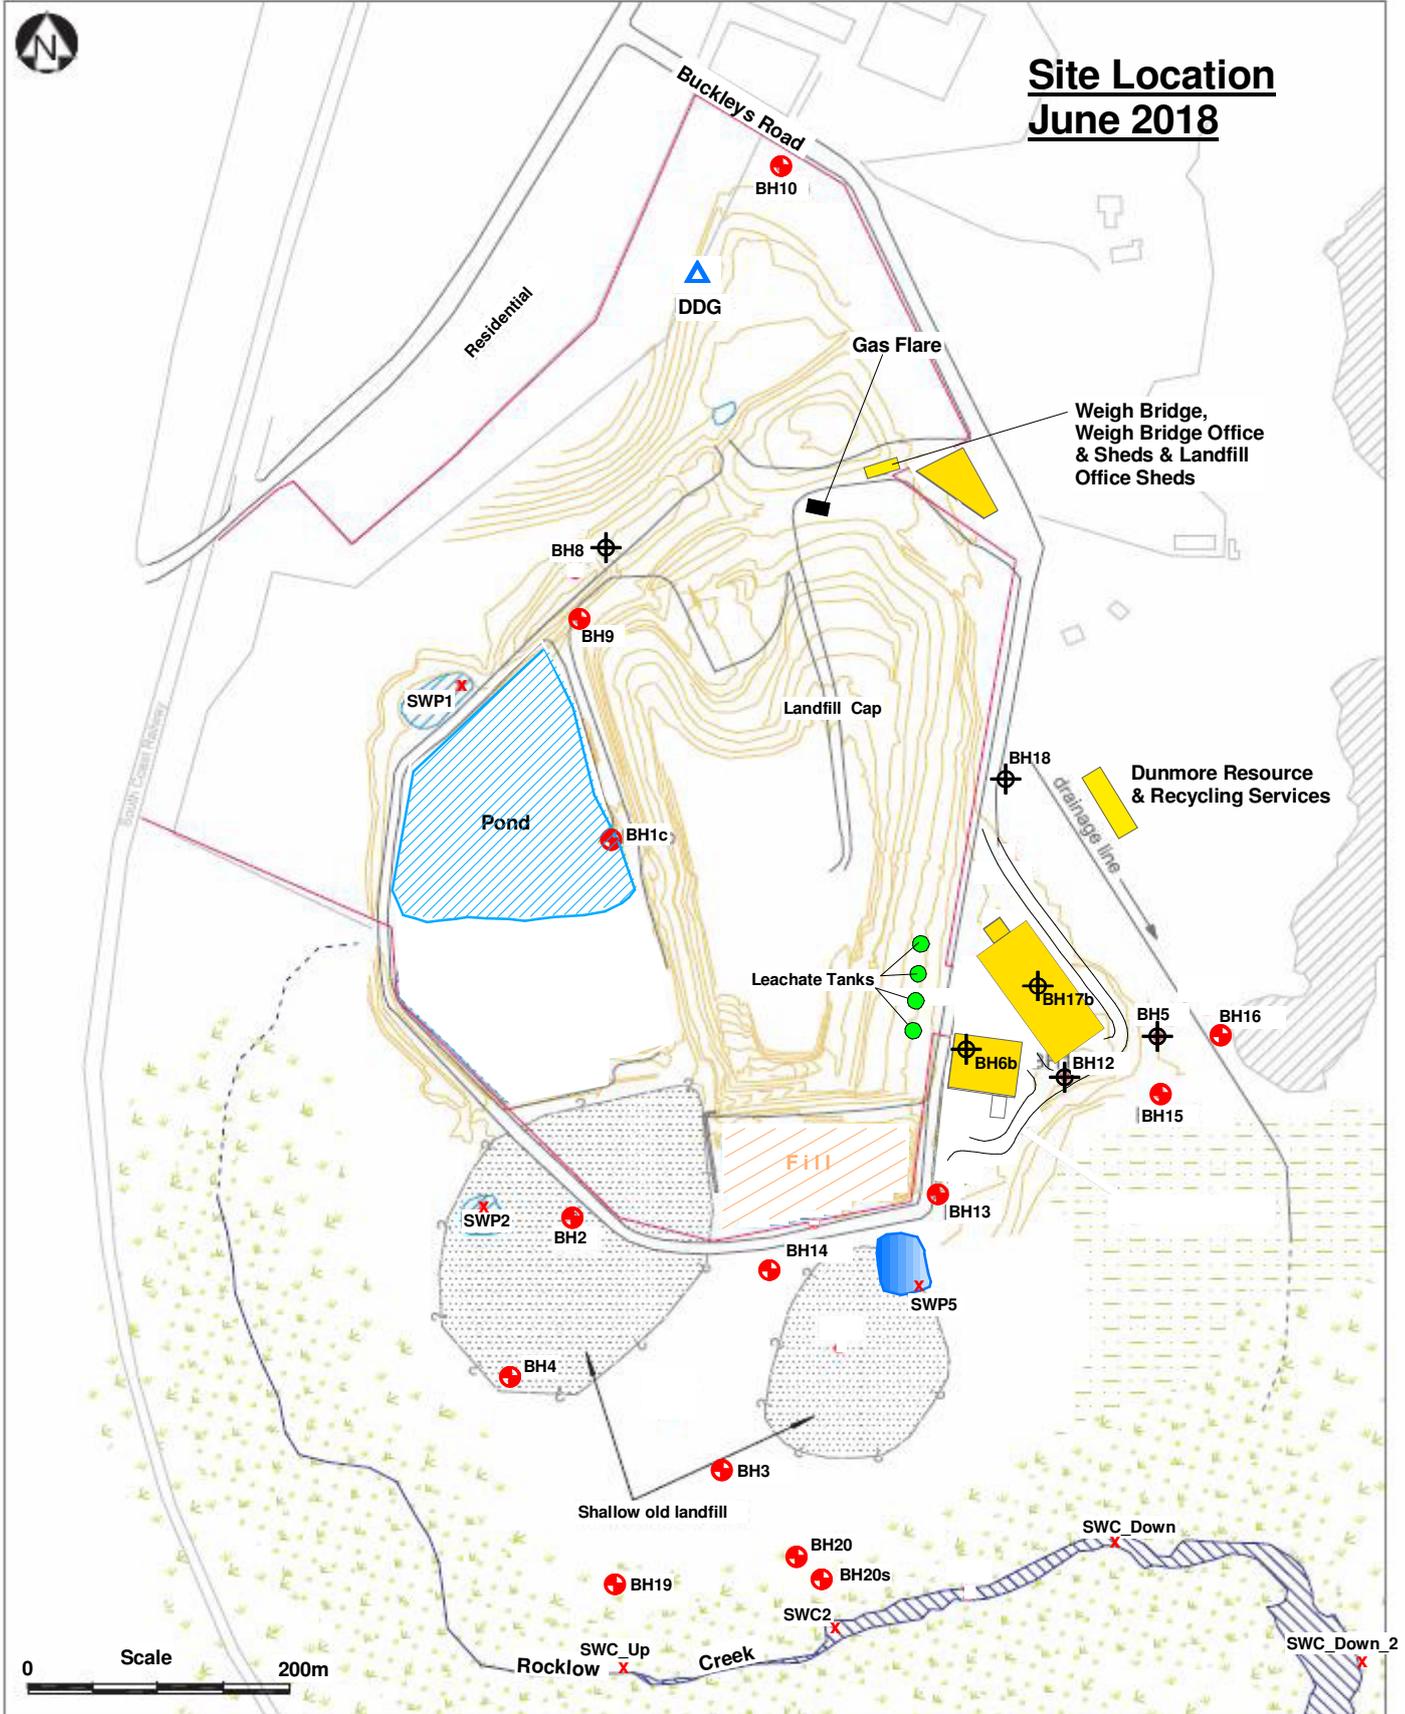
Site Location June 2018

Groundwater samples were collected from 10 monitoring bores (BH1c, BH2, BH3, BH4, BH13, BH14, BH15, BH16, BH20 and BH20s). At BH9 and BH10 only the standing water level (SWL) was measured and no samples were taken. Surface water was collected from the leachate pond (LP1), three on site retention ponds (SWP1, SWP2, and SWP4) and Rocklow Creek at four points (SWC2, SWC_Up, SWC_Down and SWC_Down_2). Sampling was unable to be taken at BH19 on 8 May as there was a blockage in the borehole caused by a watterra. SWP5 retention pond was dry. Sampling locations are shown on Figure 1 (Attachment 1).

Bore BH13 is located in close proximity to a former night soil area (Figure 1). A slight residual leachate influence has been apparent at this location in the past. Analysis of chemical data from the May 2018 monitoring round shows a slight increase of L/N ratio (12.16%) compared to the February 2018 round (7.65%). TDS levels remained stable from February 2018 to May 2018 sampling events. The chemical composition of the groundwater has remained consistent since monitoring began in 2002 (Schoeller plot BH13, Attachment 3).

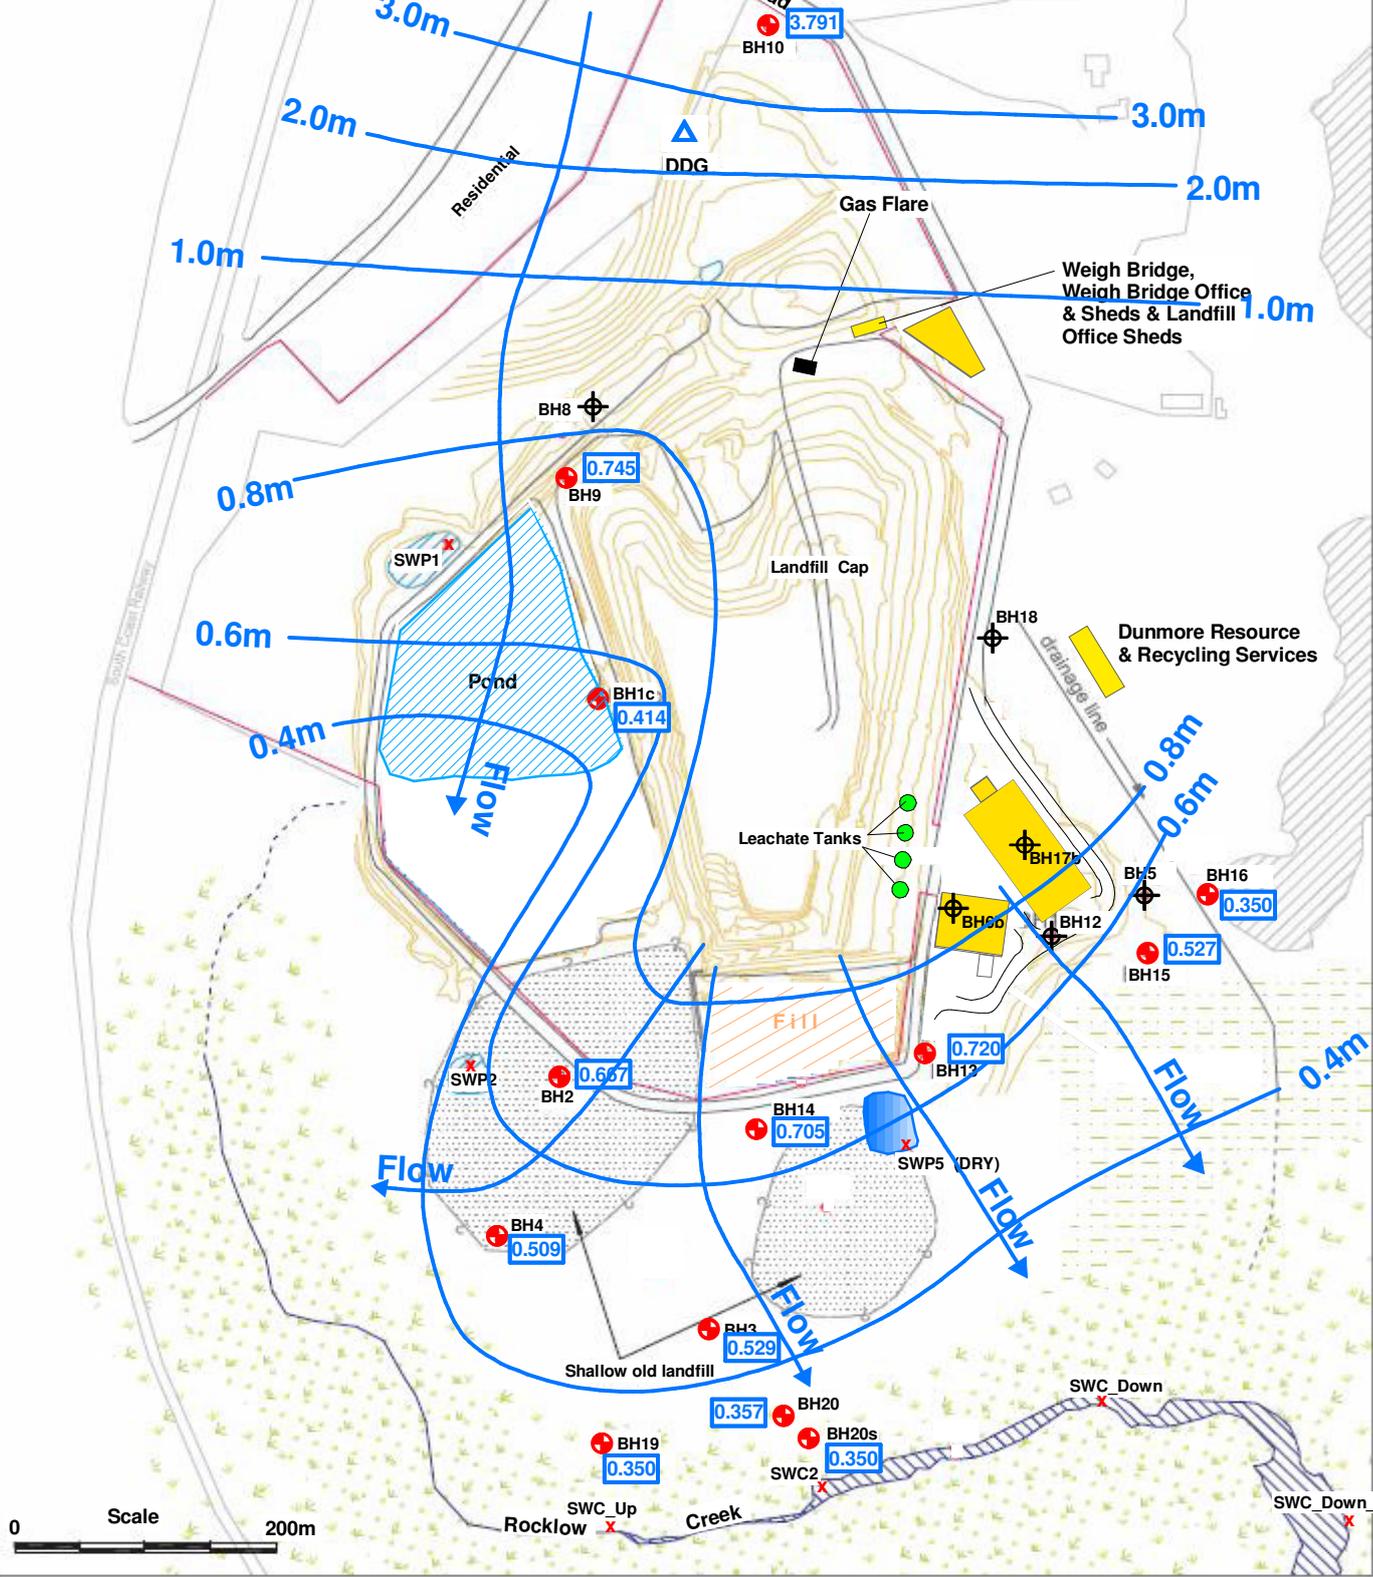
Groundwater Contours May 2018

Inferred groundwater contours from the May 2018 standing water level (SWL) measurements are illustrated in Figure 2 (Attachment 1). These were calculated using SWLs from surveyed bores. Groundwater flow direction was towards Rocklow Creek in a southerly direction similar to previous monitoring events.

Cumulative rainfall for February 2018 (116.6 mm) March 2018 (46.6 mm), April 2018 (18.2 mm) and May 2018¹ (0.0 mm) was 181.4 mm (*BOM – Albion Park Wollongong Airport weather station*) and below 1999-2018 mean rainfall for this period of the year. Groundwater levels decreased at all monitoring wells. The average of the measured standing water levels throughout the site has decreased by ~0.06 mAHD from 0.84 mAHD in February 2018 to 0.78 mAHD in May 2018.

The four surface water creek sites SWC2, SWC_Up, SWC_Down and SWC_Down_2 (Figure 2) were also sampled during the May 2018 sampling event. SWC_Down_2 is still a relatively new sampling location which was established in order to detect potential leachate impacts to Rocklow Creek originated from the eastern portion of the site (Environmental Earth Sciences NSW, 2017). SWC_Up, SWC_Down and SWC_Down_2 had high concentrations of TDS (>25,000 mg/L), notably Na^+ and Cl^- (Table 2); this is due to the tidal nature of these waters and differentiates them from landfill groundwater / surface water.

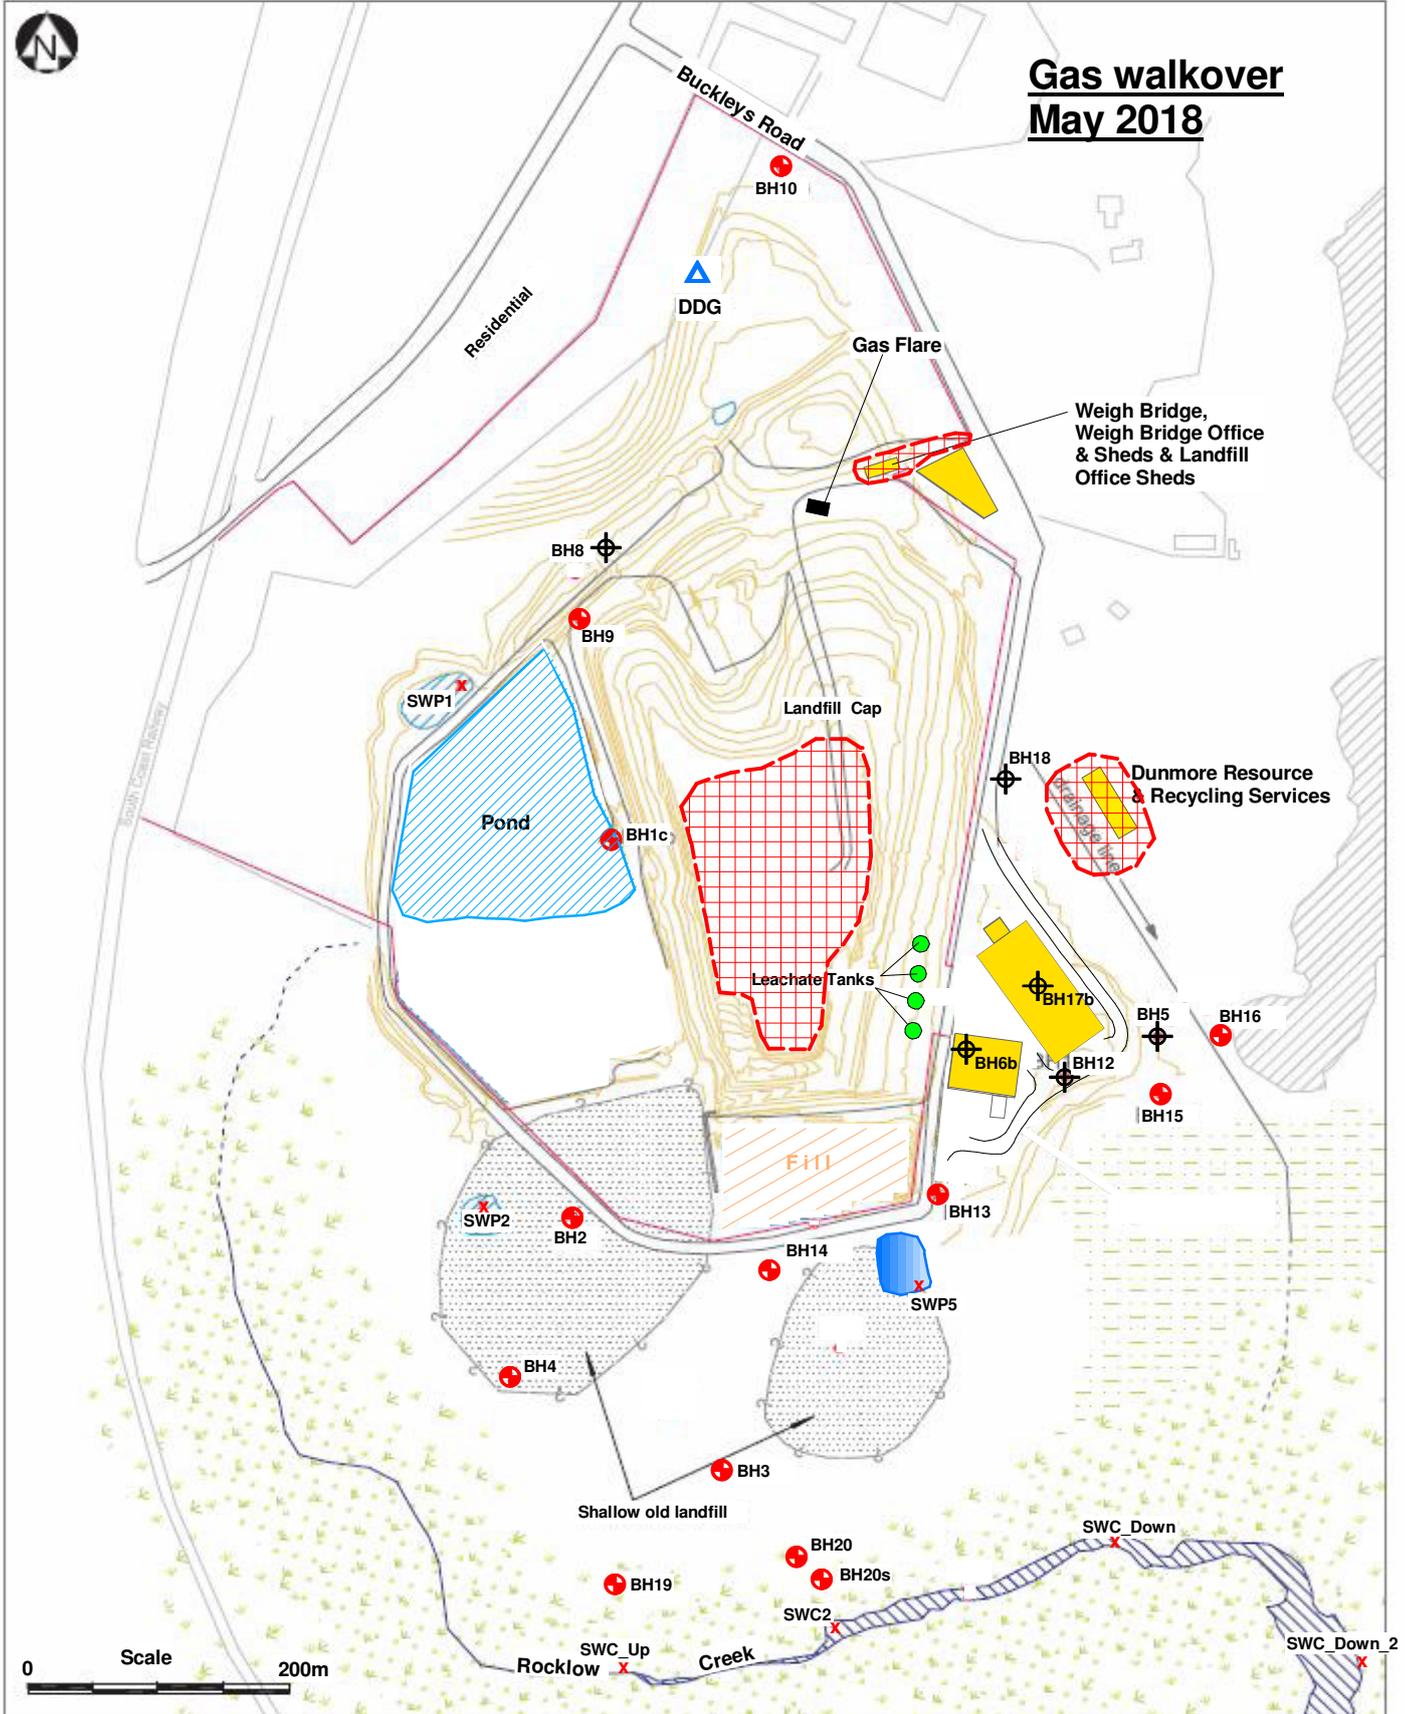
Gas walkover May 2018

Landfill gas was measured in the field using a Inspectra Laser Unit (ILU) and a GA5000 Landfill Gas Monitor (GA5000). Measurements were taken within and around all buildings in a 250 m radius from the current landfill cell as well as across the landfill cap (gas walkover grids of May 2018 round are presented in Figure 3).

All readings were below the site specific criteria outlined in EPL no. 5984 as the NSW EPA (1996) reporting threshold of 1.25 % v/v CH₄ within onsite buildings and therefore pose no direct risk. Readings were below the threshold concentration for closer investigation and potential action (500 ppm or 0.05 % v/v, NSW EPA [1996], Table 5). No landfill gas was detected with the GA5000. Continued monitoring with both the GA5000 and ILU will be undertaken at quarterly monitoring events.

Gas concentrations detected at all buildings assessed on site were below guidelines and therefore no action was required. Gas concentrations across the landfill cap were also within the guidelines. However, as landfill gas exceedances were recorded in May 2017 we recommend continued monitoring with an Inspectra Laser Unit and GA5000 Landfill Gas Monitor.

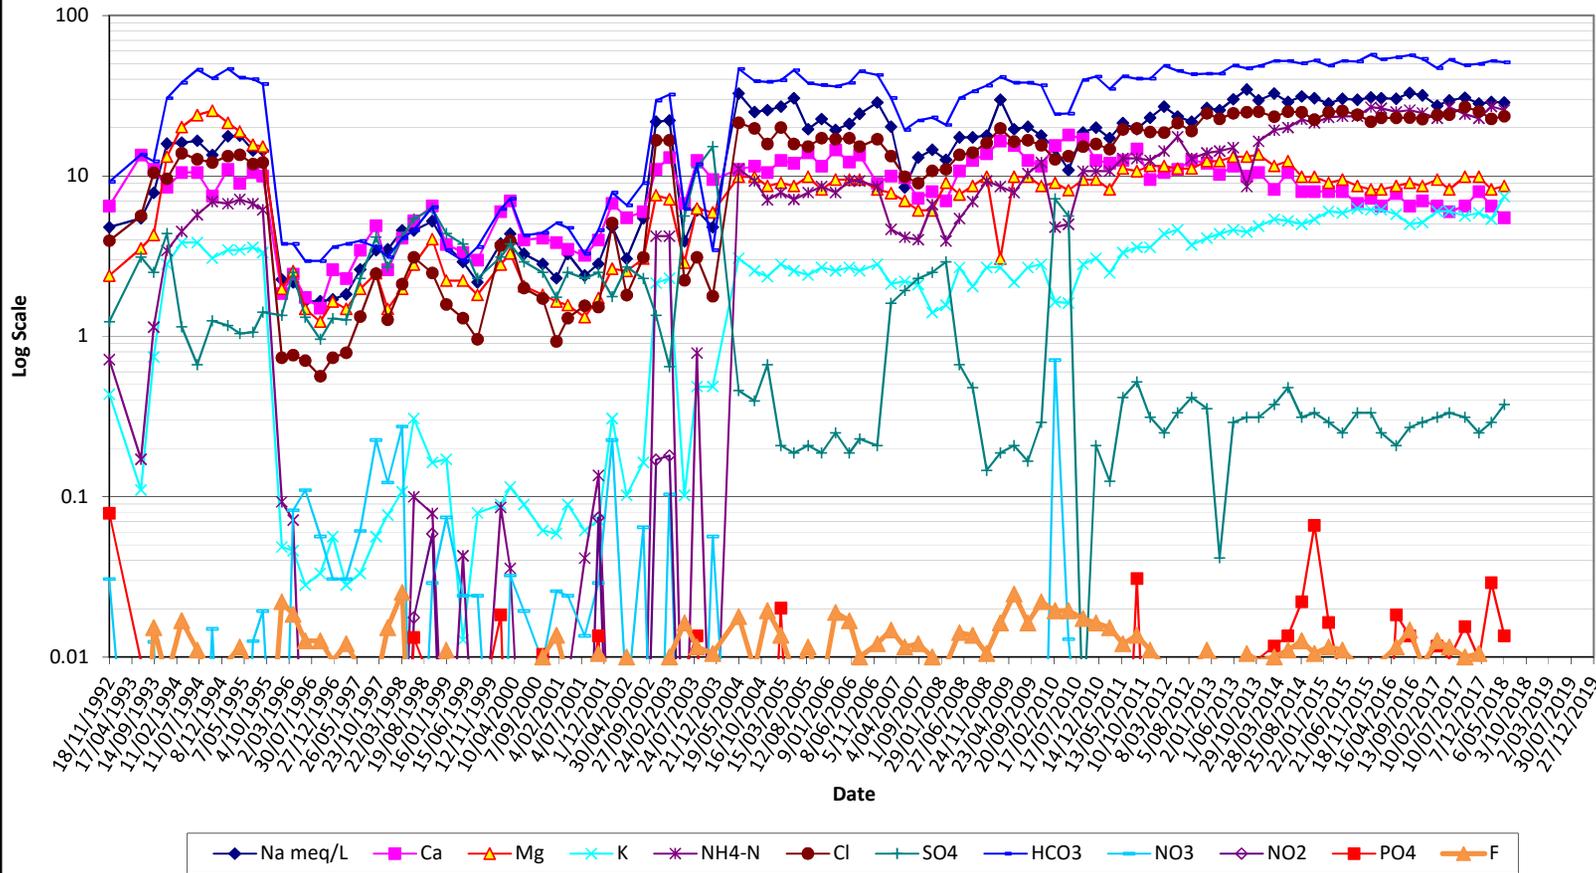
Bore BH1c is located near the old unlined landfill cell and intercepts leachate within the cell. As such the chemical signature of this bore has historically contained elevated leachate indicators in comparison to other monitoring bores (Schoeller plot BH1 a/b/c, Attachment 3). This continued during the current monitoring event and the groundwater was found to have a light brown colour, and leachate odour noted in combination with elevated TDS (3,940 mg/L), K⁺ (290 mg/L) [resulting in low Ca/K – 0.74] and NH₄⁺-N (360 mg/L) concentrations. The low levels of oxygen (0.05 ppm, Table 1) and presence of soluble Fe²⁺ indicate an anaerobic state and biochemical demand in response to microbial respiration. BOD has fluctuated since the bore was installed, ranging from 830 mg/L to 6 mg/L. BODs have remained at similar levels (6-8 mg/L) since August 2016. In May 2018, there was a slight fluctuation in BOD with levels rising to 12 mg/L. Further evidence of microbial activity / respiration is elevated HCO₃⁻ resulting in a low Cl/HCO₃⁻ ratio of 0.46 (Table 4). This suggests some degradation of the leachate plume has occurred in this monitoring bore.

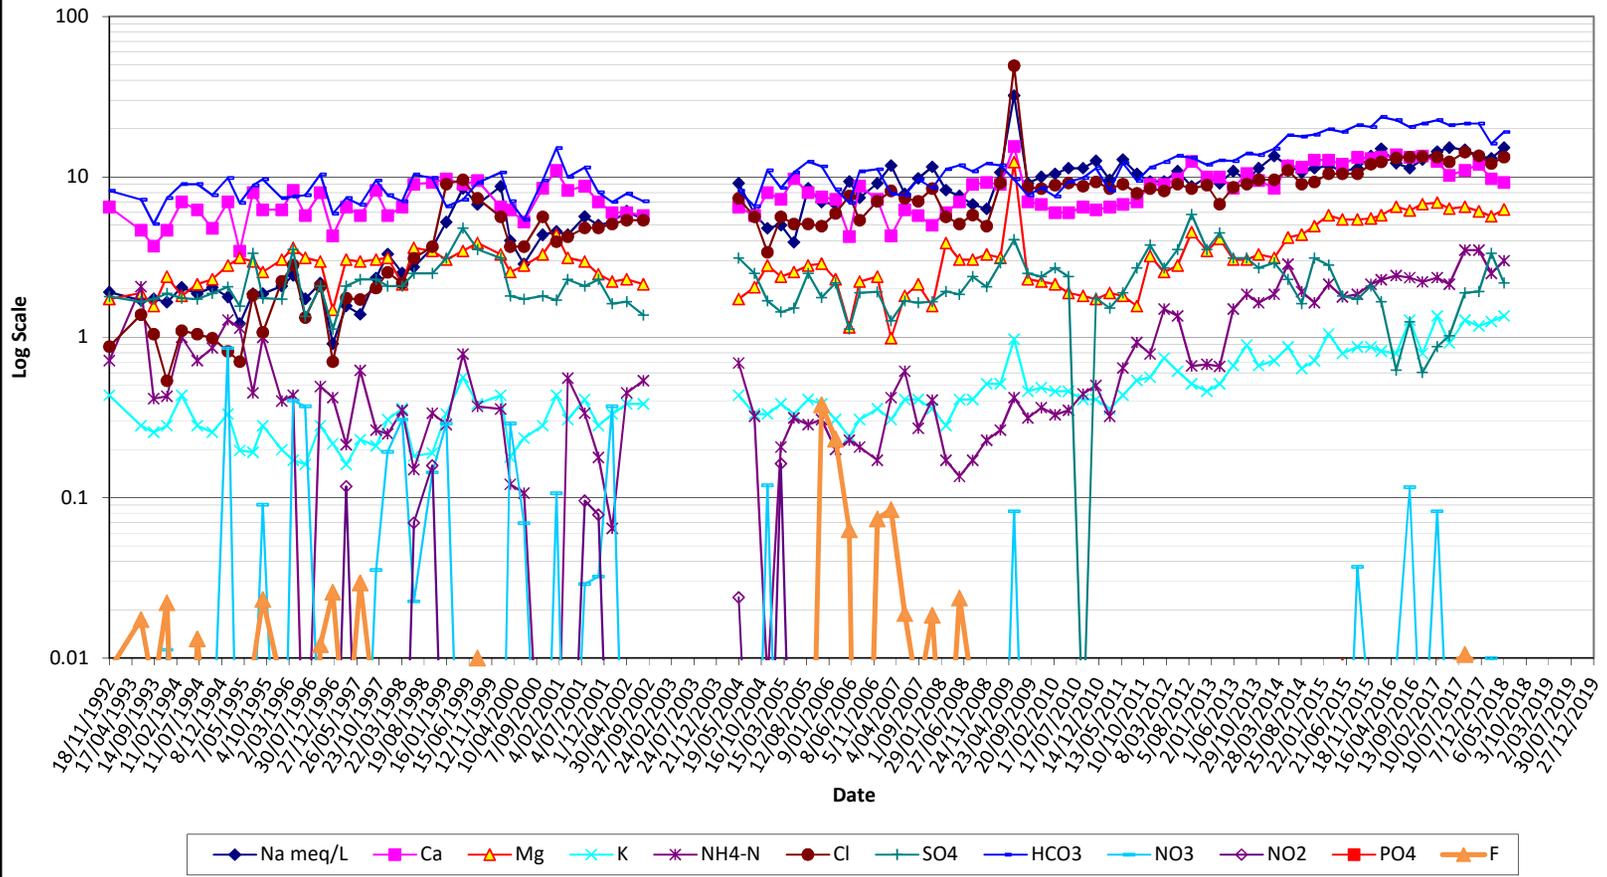
Bore BH2 is located down gradient from the old unlined landfill cell. Historically elevated levels of NH₄⁺-N indicate some leachate impact at this location. NH₄⁺-N concentration at BH2 showed an increasing trend since 2010 and reached its historical maximum in August 2017 and November 2017 (49 mg/L in both months). NH₄⁺-N concentration increased in the May 2018 monitoring round to a level of 42 mg/L (up from 35 mg/L in February 2018). Bicarbonate (HCO₃⁻), Na⁺ and Mg²⁺ concentrations in groundwater have shown an increasing trend since January 2008 (Table 2, Schoeller plot BH2, Attachment 3). Calcium (Ca²⁺) concentrations slightly decreased whilst potassium (K⁺) and chlorine (Cl⁻) slightly increased since the last monitoring round (Table 2, Schoeller plot BH2, Attachment 3). This is representative of the small increase in TDS. Low oxygen and negative redox (Table 21) continue to suggest microbial respiration and therefore degradation of the leachate is occurring at this location. Additionally, a leachate odour was noted.

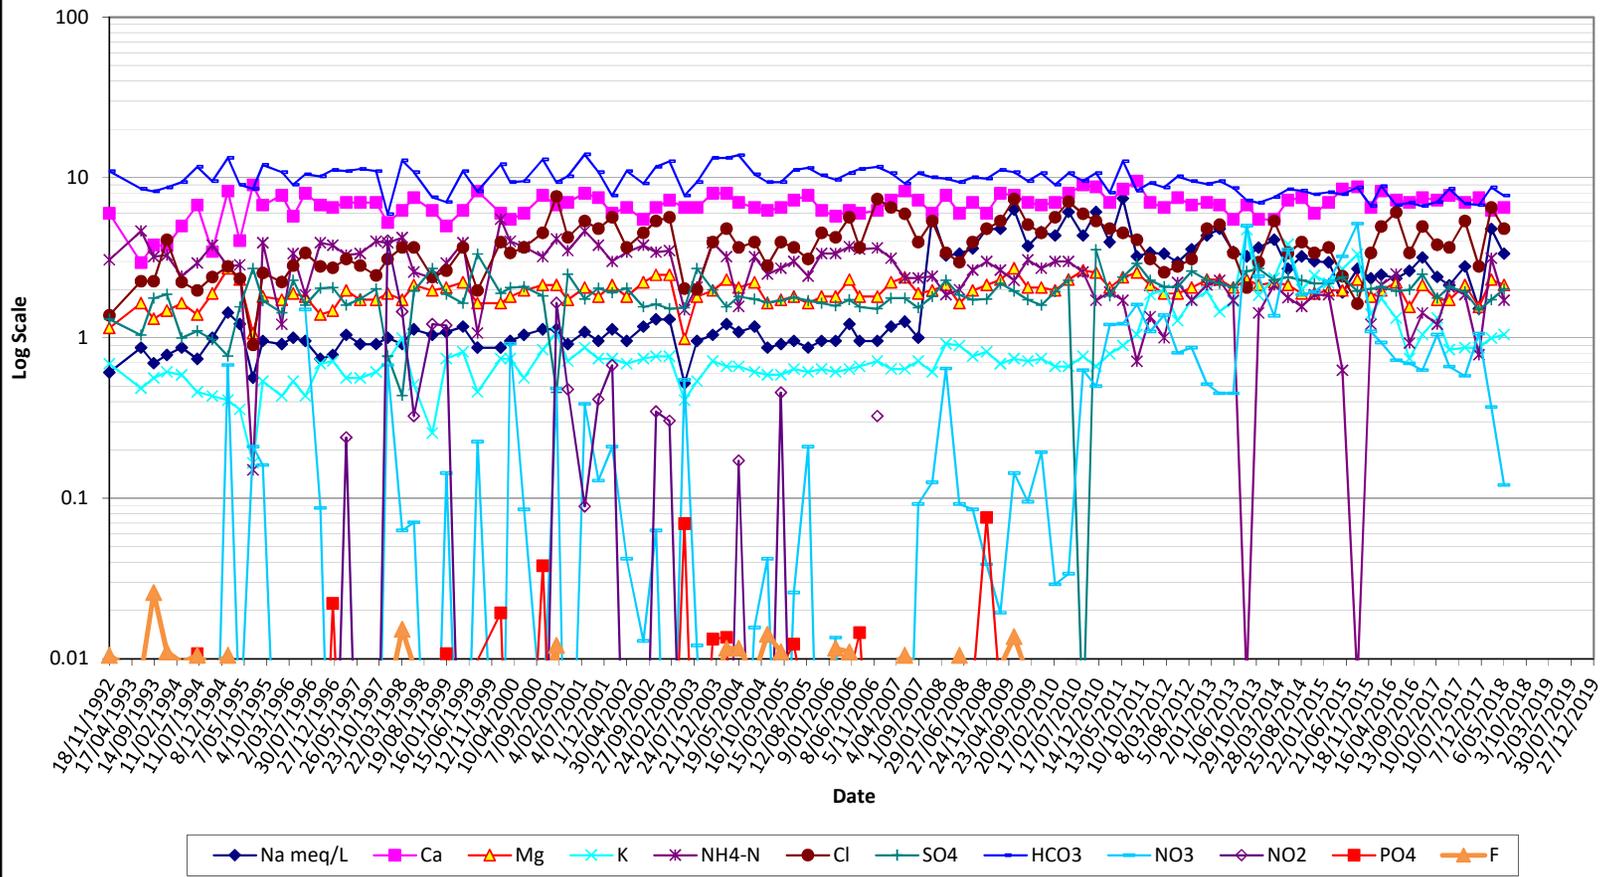
Groundwater from bore BH3 reported increases in concentration of one native ion (Ca²⁺) as well as one non-native ion (K⁺) since last monitoring round. Comparatively, the

concentration of Na^+ , Mg^{2+} , $\text{NH}_4^+\text{-N}$, Cl^- and HCO_3^- decreased. The L/N ratio (31.12%) has decreased since the February 2018 monitoring round (40.30%). However, due to the low TDS (<1000 mg/L) the L/N ratio must be used with some caution. Long term trends (since 1992) show that K^+ concentrations had generally increased from February 2011 until November 2015, the levels then returned to historical levels by August 2016. Nitrogen species (NO_3 , NO_2 and $\text{NH}_4^+\text{-N}$) have remained within historical levels. It was reported and verified during the drilling of BH3 that old unconfined waste dumps were in the vicinity of bore BH3 (outside the designated cells near bore BH2). This waste is likely to have an impact on the results.

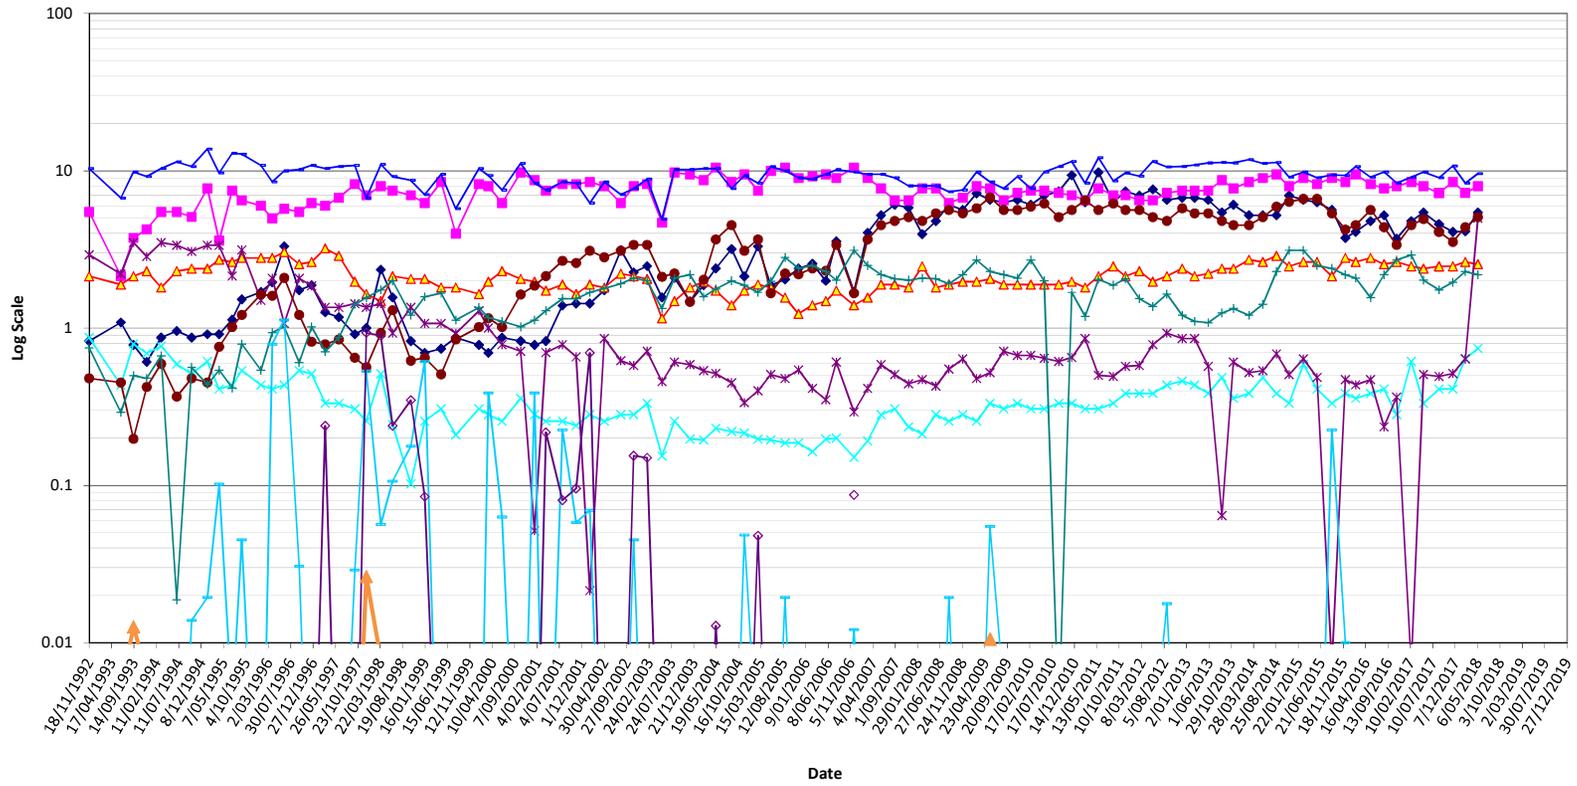
The L/N ratio at bore BH4 showed a slight decrease in the May 2018 round (11.42%) — in February 2018 monitoring round the L/N ratio was 12.50% at this location. The L/N ratio at this location had not exceeded 10% since February 2003. A slight decrease in the concentration of $\text{NH}_4^+\text{-N}$ (7.00 mg/L – down from 8.90 mg/L in February 2018) and relatively stable concentrations of native ions Na^+ , Ca^{2+} and Mg^{2+} can be attributed to the decrease in L/N ratio however this value should be used carefully due to low TDS <1000 mg/L. BH4 is placed on the border of an historic shallow landfill site and down gradient of landfilling activities. This area should be continually monitored to determine water quality in this area.

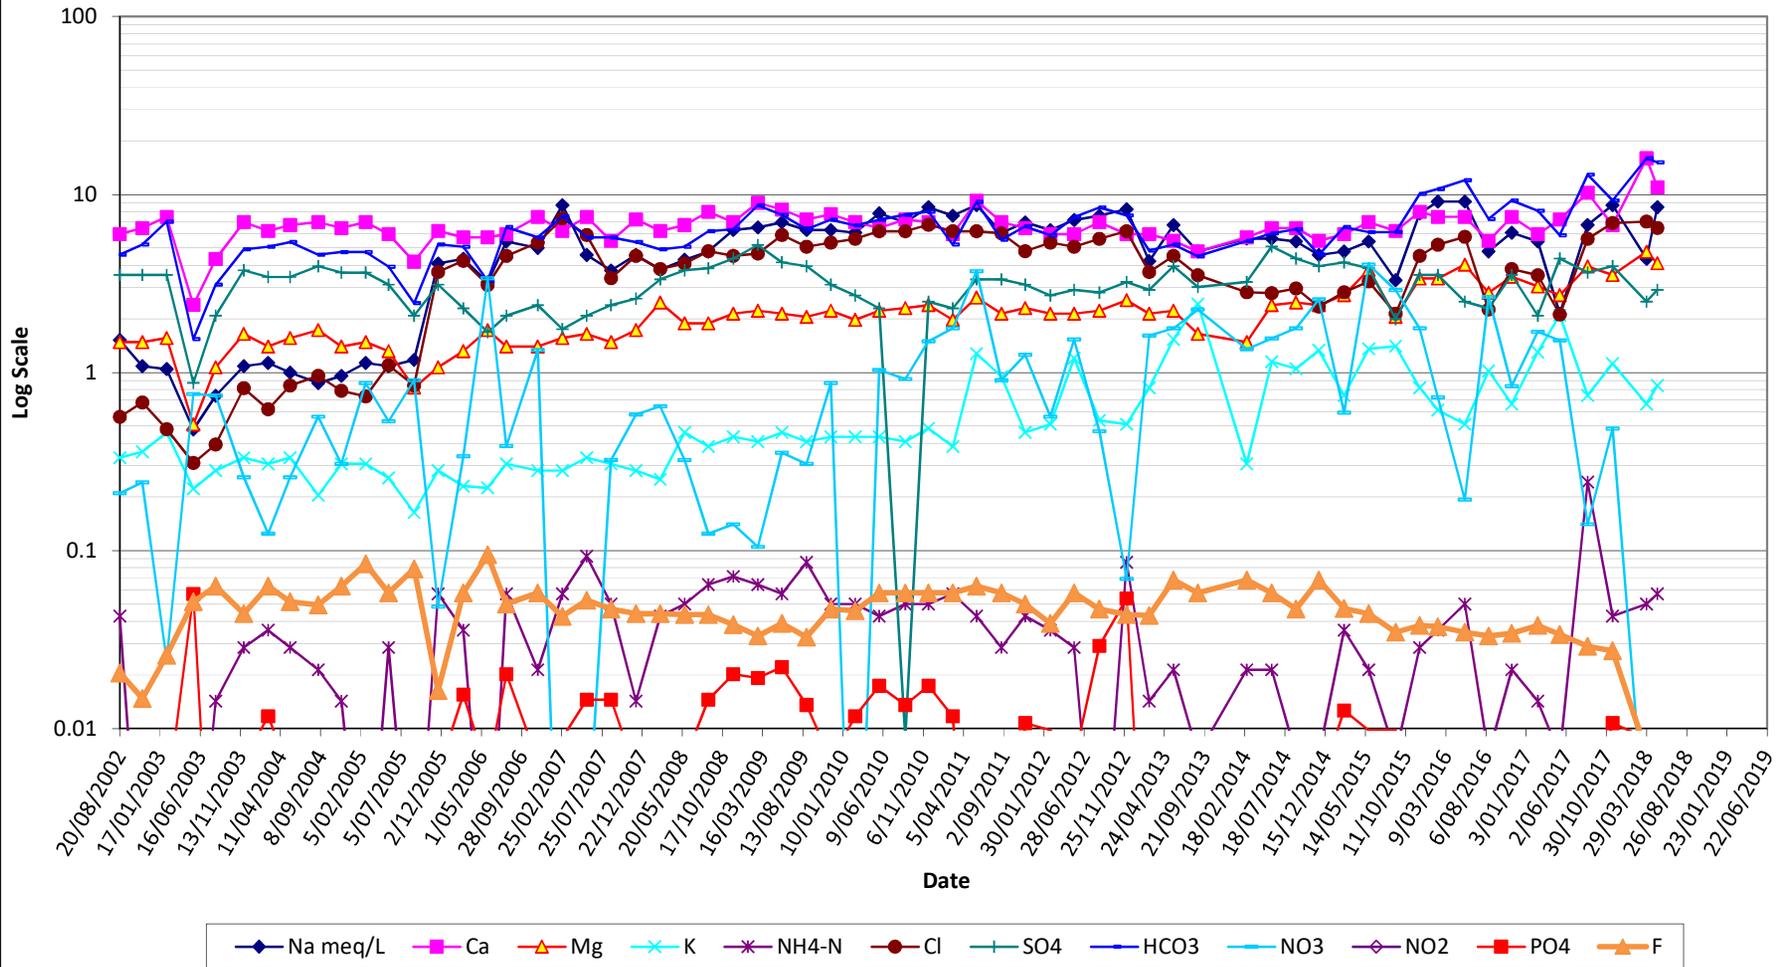
The L/N ratio at bore BH14 showed a slight increase in the May 2018 round (7.29%) — in February 2018 monitoring round the L/N ratio was 5.61% at this location. Concentrations of K^+ were higher in the May 2018 monitoring period compared to February 2018 levels (Schoeller plot BH14, Attachment 3). $\text{NH}_4^+\text{-N}$ and NO_3^- concentration remained stable however NO_3^- levels have been historically high at this location in the past. Bore BH14 is strategically placed down gradient of landfilling activities and should be continually monitored to determine the water quality in this area given its history of leachate impact.

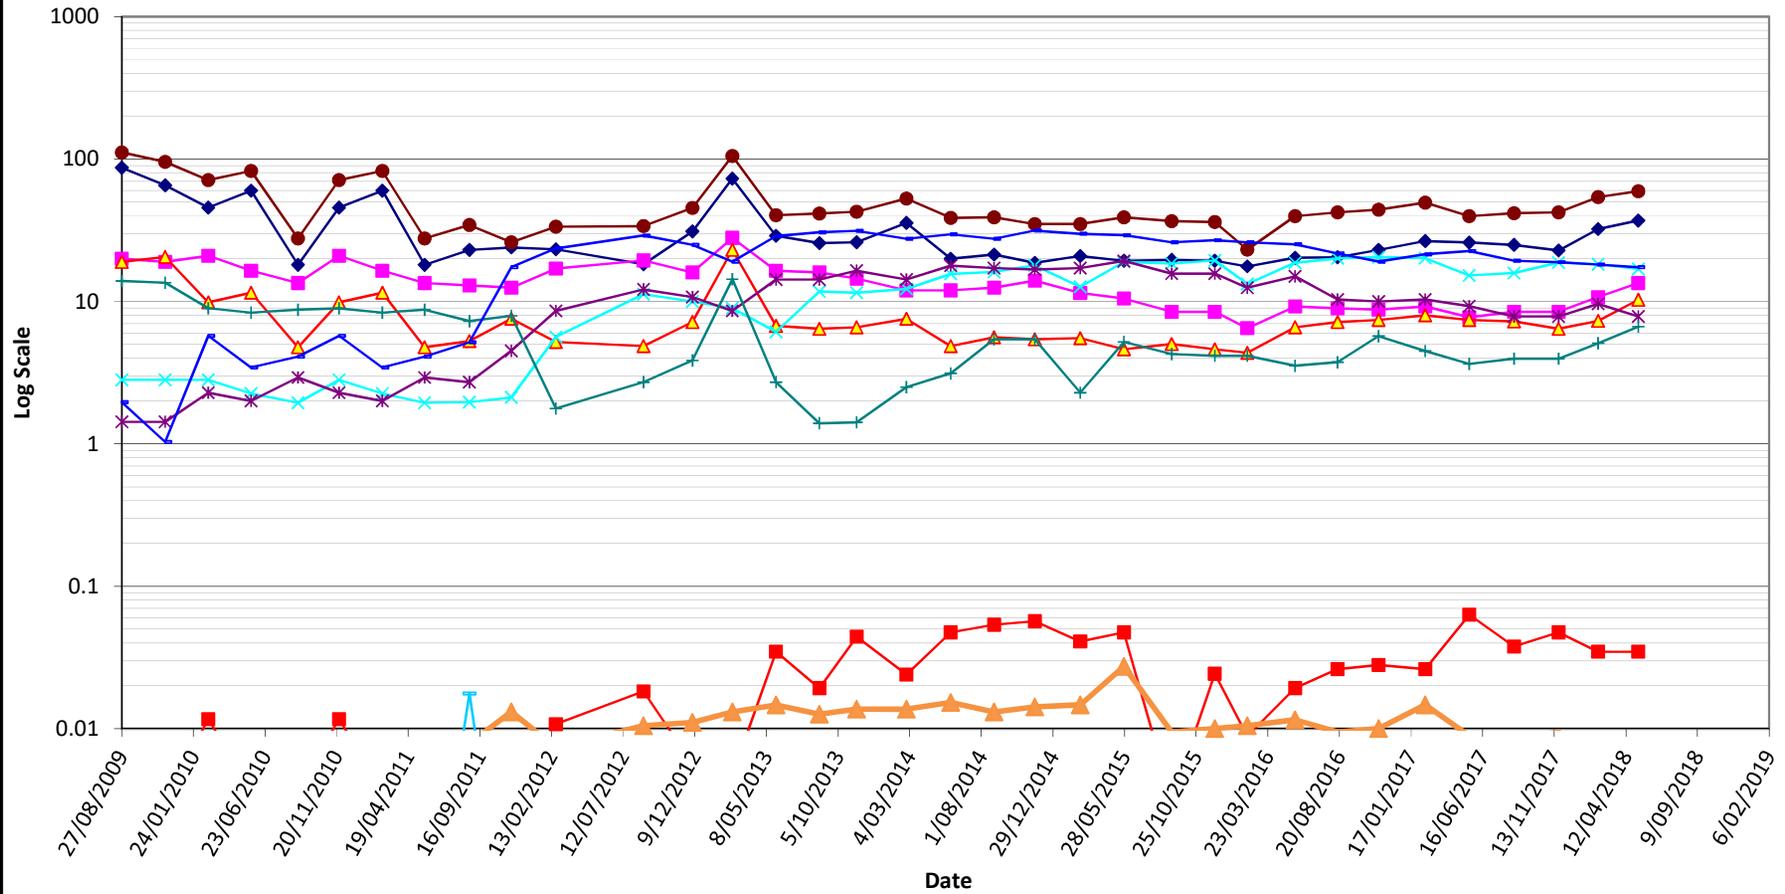
Bore BH15 displayed a decrease in L/N ratio however the value remains high at 61.86%. The decrease can be attributed to the decreased levels of K^+ and $\text{NH}_4^+\text{-N}$ concentrations and the increase in Na^+ , Ca^{2+} and Mg^{2+} concentrations. The K^+ /TDS ratio of 13.52% was high when compared to non-leachate influenced sites generally with K^+ /TDS < 3 (Schoeller plot BH15, Attachment 1). Ammonium ($\text{NH}_4^+\text{-N}$) remains elevated at 110 mg/L, compared to other non-impacted locations at the site, which is consistent with previous monitoring rounds. Field measurements of a negative redox (negative ORP) and low dissolved oxygen are indicative of a reducing environment. This reducing environment promotes the elevated levels of soluble Mn^{2+} (0.67 mg/L) and Fe^{2+} (13 mg/L). Additionally, bore BH15 is located within a swampy environment where microbiological activity drives reducing reactions that can result in naturally high levels of leachate indicators such as organic carbon and HCO_3^- . Furthermore, bore BH15 is located near a drainage line within the groundwater bearing zone <0.5 m below the ground surface. Groundwater therefore has the potential to be influenced from local onsite and offsite works and surface water.

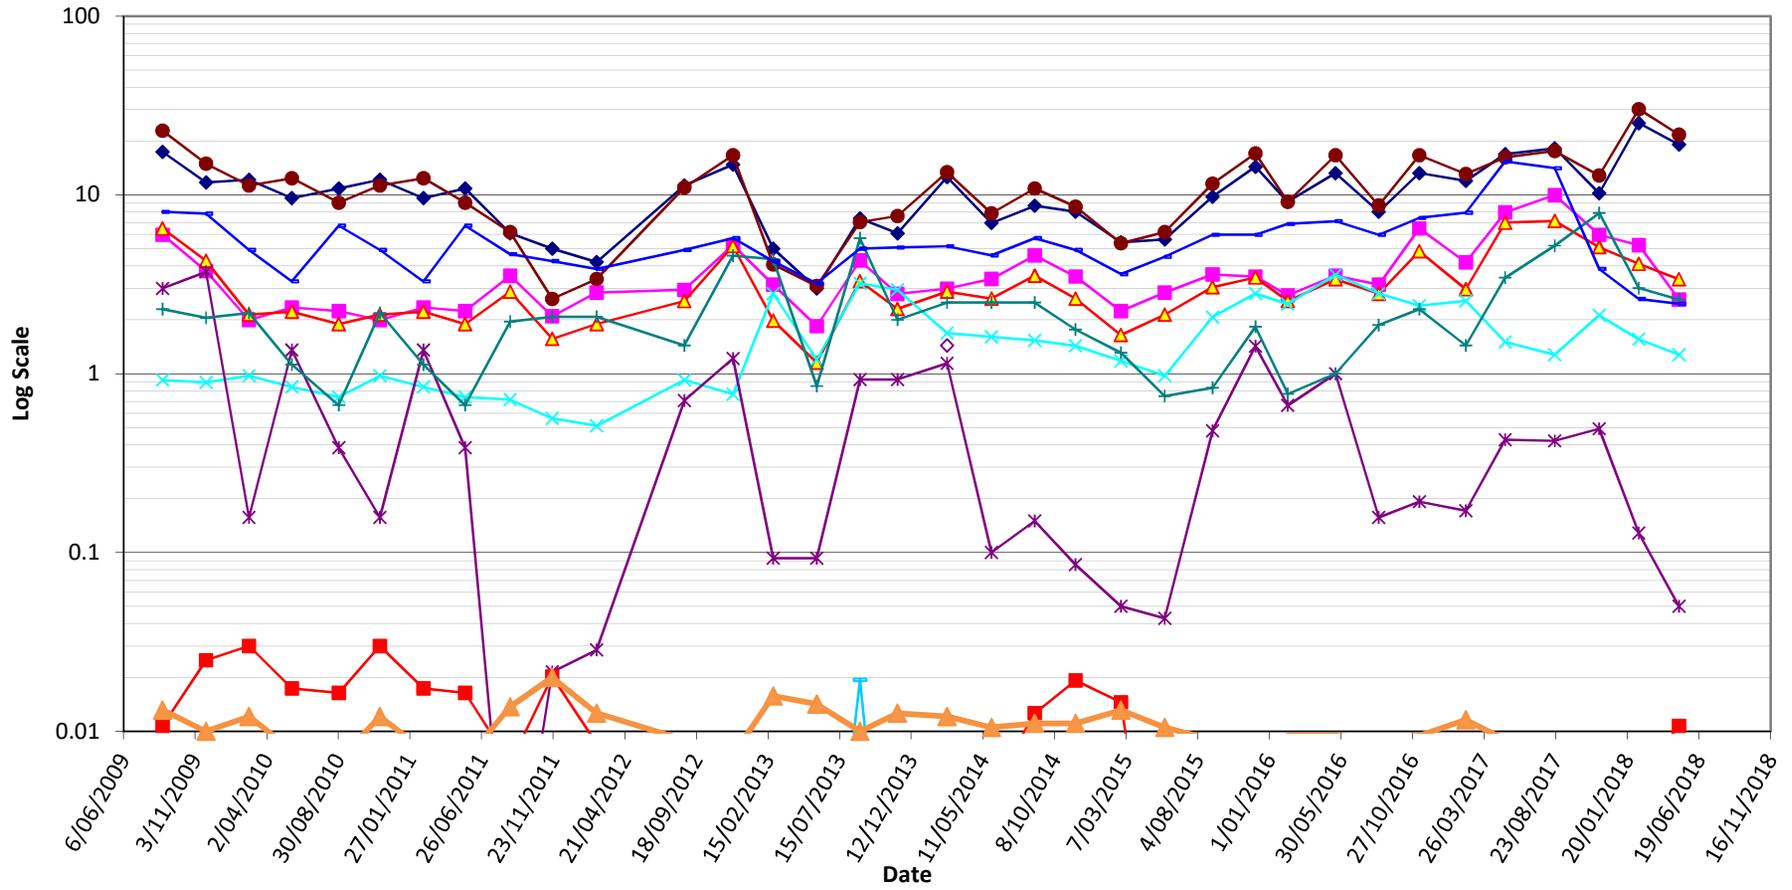
Bore BH16 is located in a swampy area with groundwater field observations recording a dark brown colour and a sulfuric odour. The sampled redox potential indicates a reducing environment (-137 mV), which may have an influence in the historical dominance of $\text{NH}_4^+\text{-N}$ over NO_3^- . This round $\text{NH}_4^+\text{-N}$ concentrations were 0.7 mg/L. Groundwater sampling in May 2018 indicated limited to no leachate impact at BH16 which was represented by the L/N ratio of 9.53%. The L/N ratio increased slightly in May 2018 (9.53%) compared to February 2018 (8.56%). This can be attributed to the decrease in concentrations of the native ions Na^+ , Ca^{2+} and Mg^{2+} and the stable concentrations of the non-native ions (K^+ and $\text{NH}_4^+\text{-N}$). Bores BH15 and BH16 are located close to a drainage channel where offsite impacts can readily influence the chemical characteristics of the shallow groundwater and should continue to be monitored for fluctuations.

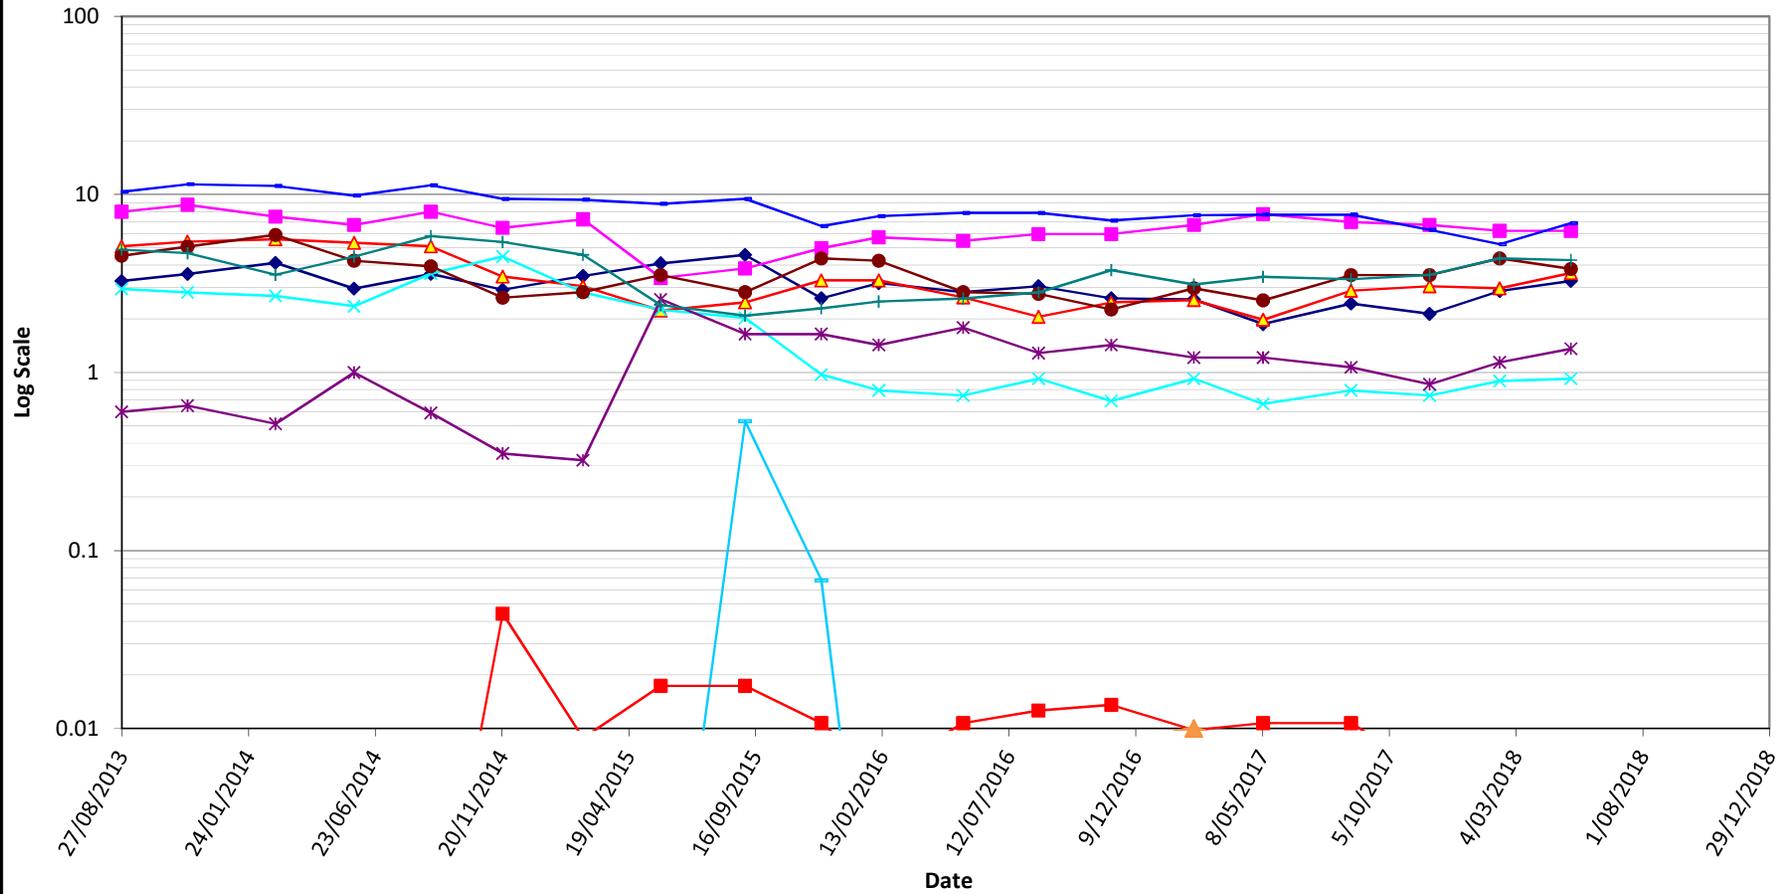
Bore BH20 is located down gradient of the landfill, leachate ponds and shallow old landfill. This bore was positioned to assess the chemical characteristics on the boundary of the landfill site. Field observations at bore BH20 recorded a negative redox (-114 mV) with a clear colour of the groundwater and H_2S odour. The L/N ratio (22.58%) in the May 2018 round was stable compared with the last monitoring round. The TDS remained relatively low (850 mg/L) making the L/N susceptible to natural variations or fluctuations in chemistry. Chemical characteristics of the bore show groundwater is low in Na^+ , with a moderate Ca/K and K/TDS ratio (Table 4). Ammonium levels remained elevated at 16 mg/L however other landfill indicators were low or absent.
