May 2018 Quarterly Environmental Monitoring – Dunmore Recycling and Waste Disposal Depot, Dunmore, New South Wales.

1.0 Introduction

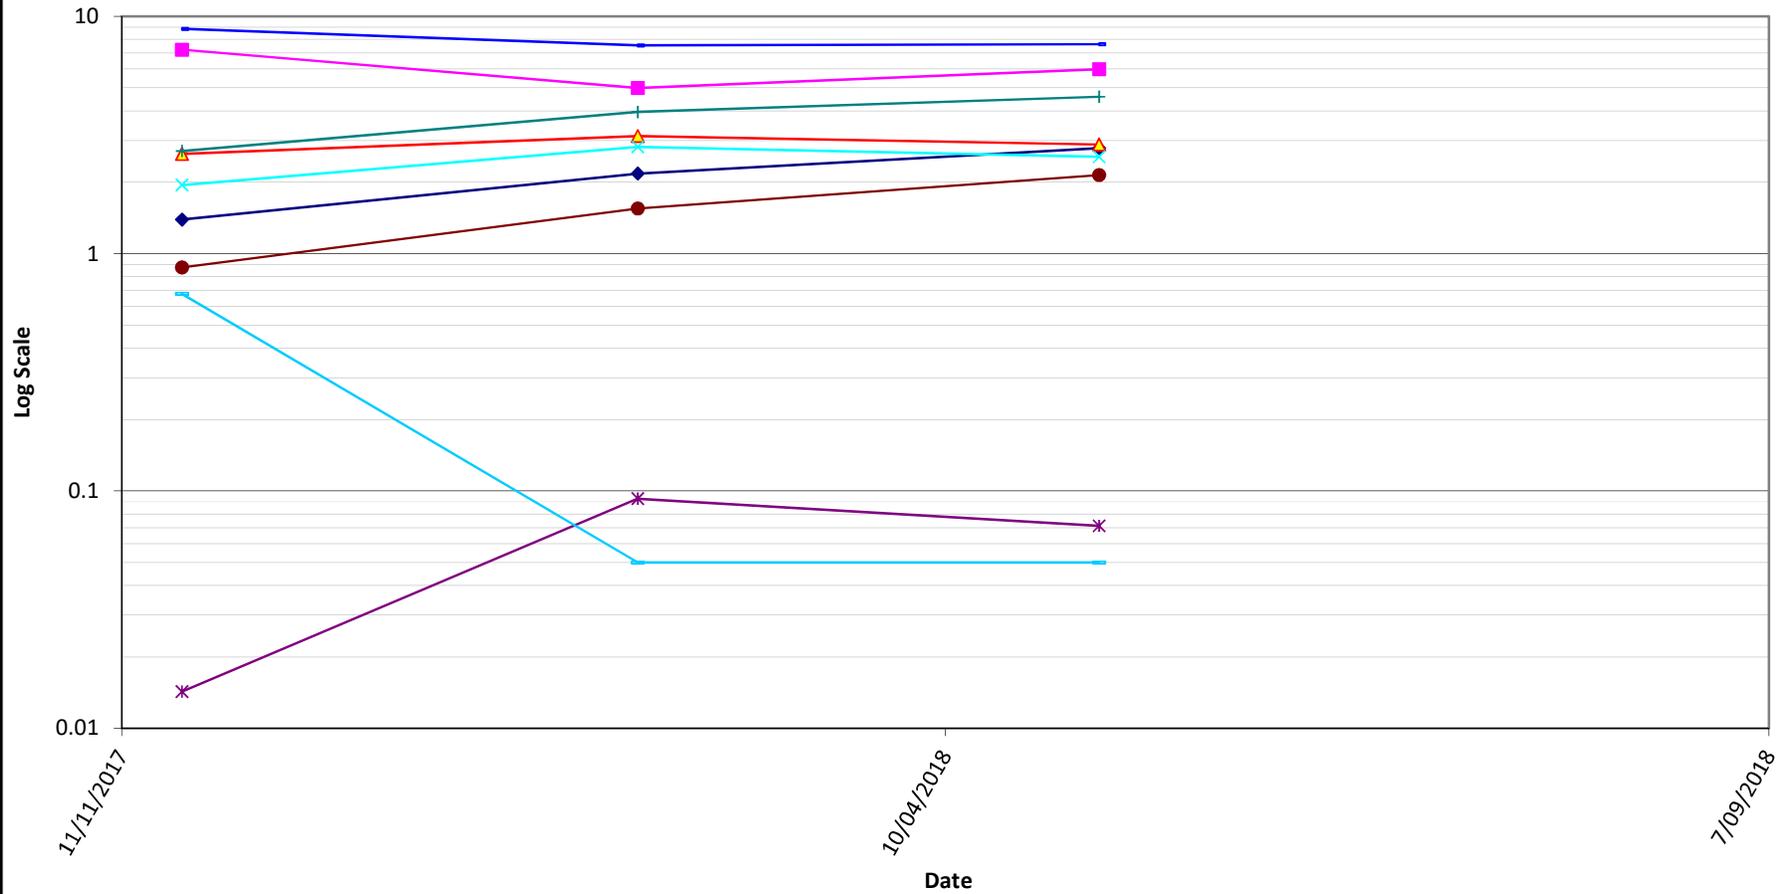
Bore BH20s is located directly adjacent to BH20 but at a shallower depth – *screened intervals of BH20 and BH20s are 6.0-9.0 mBGL and 1.5-4.5 mBGL respectively*. Similarly, this bore was positioned to compare the chemical characteristics on the boundary of the landfill site in order to locate potential transport pathways to Rocklow Creek. In February 2018, field measurements at bore BH20s recorded a negative redox (-29 mV), clear colour of the groundwater and no odour was detected. The L/N ratio (47.53 %) continued to indicate potentially high leachate impact at this site. However, TDS is relatively low (835 mg/L) making the L/N susceptible to natural variations or fluctuations in chemistry. Chemical characteristics of the bore show groundwater was low in Na^+ , with a moderate Ca/K and K/TDS ratio (Table 4). Ammonium levels (1.0 mg/L) have decreased slightly since February 2018 but remain lower than those seen at the deeper BH20 bore. Nitrate levels have stabilised in May 2018 (3.1 mg/L) from the peak of 42 mg/L in November 2017. It was previously thought that high nitrate levels in this shallower bore location was indicative of nitrification throughout the soil profile. Continued monitoring at this location will be necessary to determine potential transport pathways to Rocklow Creek.

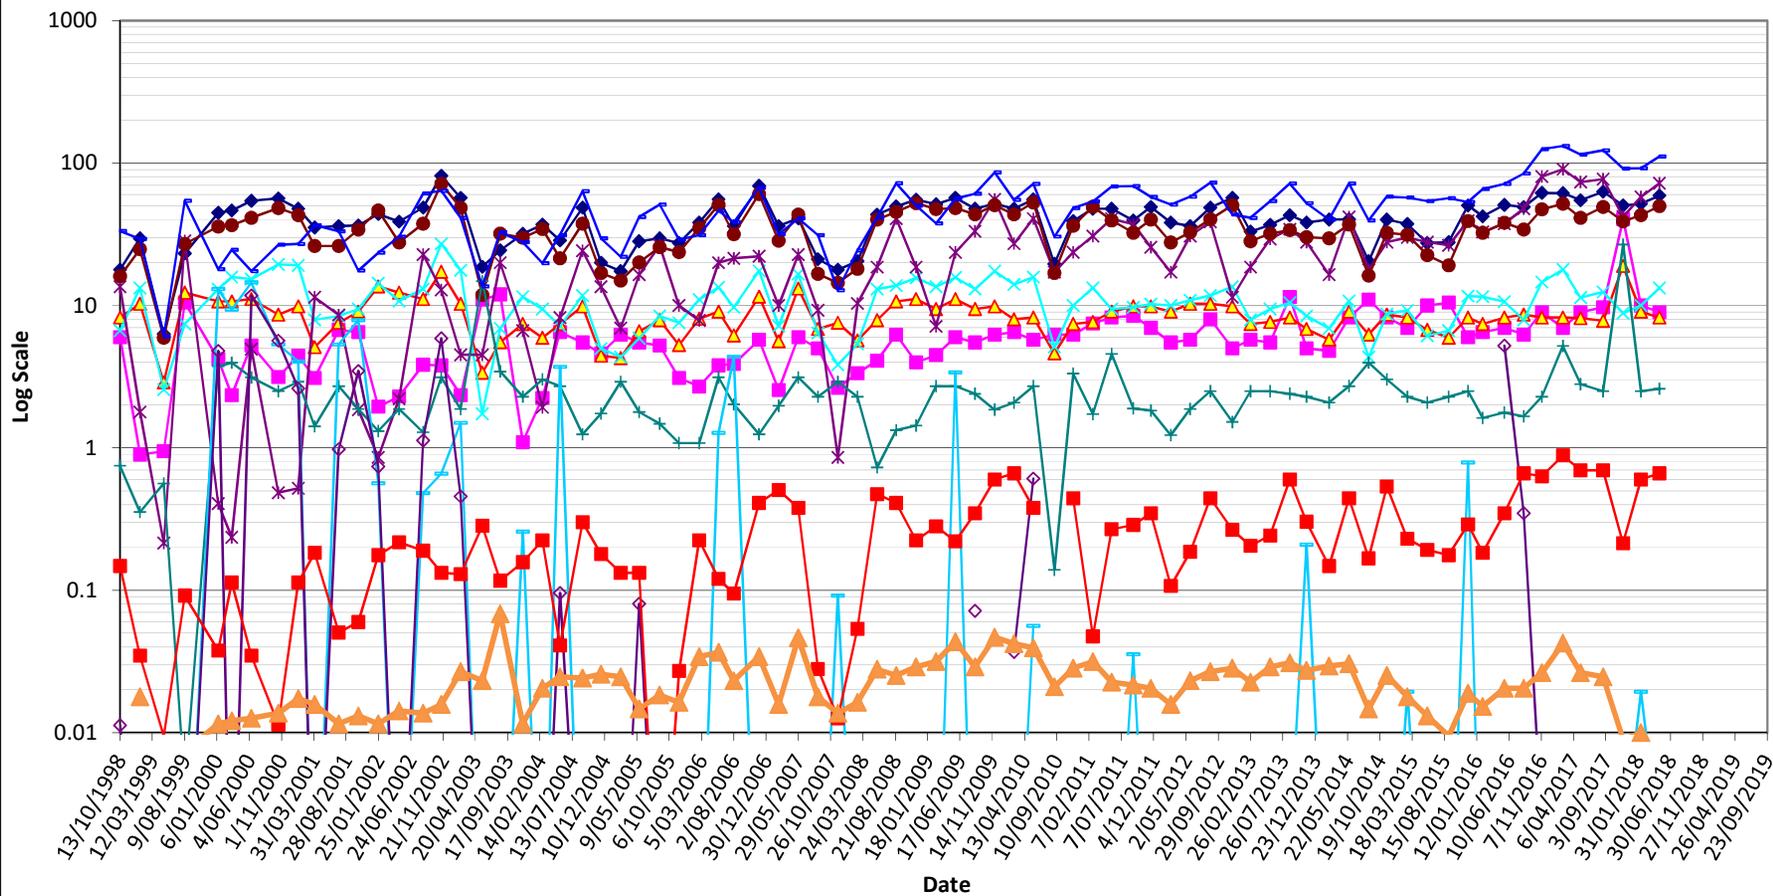
LP1

The chemistry of leachate water at the Dunmore Recycling and Waste Disposal Depot is significantly different when compared to the surface and groundwater chemistry of non-leachate influenced bores. This is demonstrated through comparison of chemical data presented in Table 2. In particular TDS, BOD, TOC, Na^+ , $\text{NH}_4^+\text{-N}$, K^+ , HCO_3^- , PO_4 and total iron concentrations are generally elevated in leachate pond water compared to other monitoring bores (Schoeller Plot Leachate, Attachment 3). Ionic ratios (Table 4) such as low Ca/K (1.00) and high Na/Ca and L/N ratios represent landfill leachate chemical characteristics. These chemical characteristics have been relatively stable over the past 10 years of monitoring.

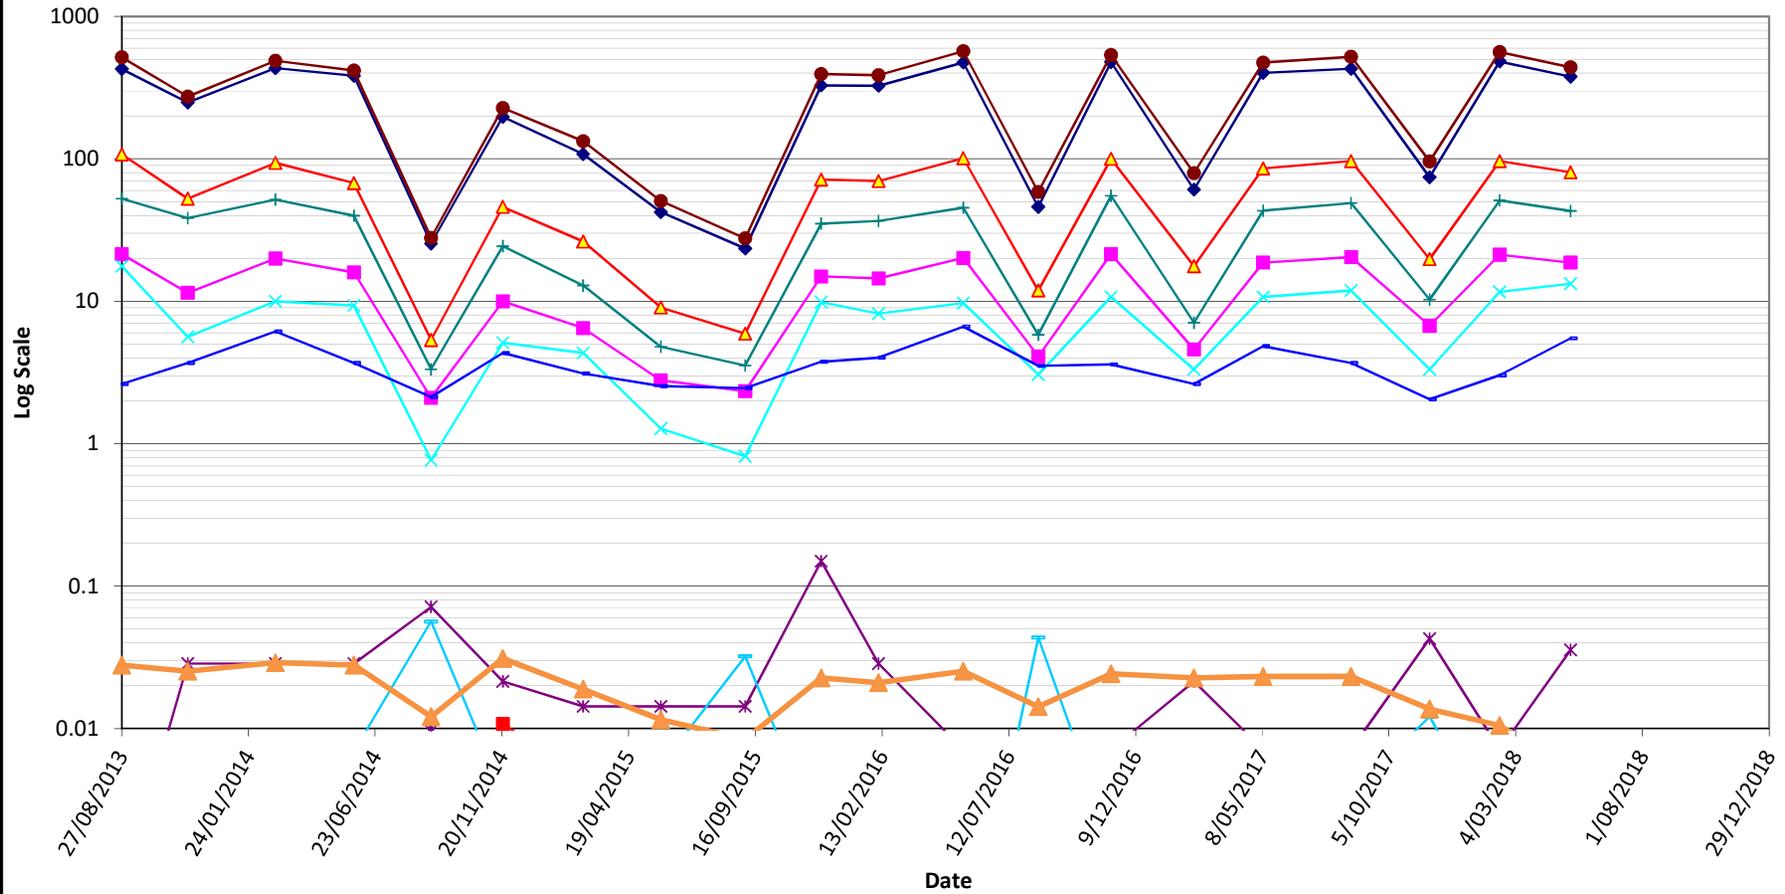
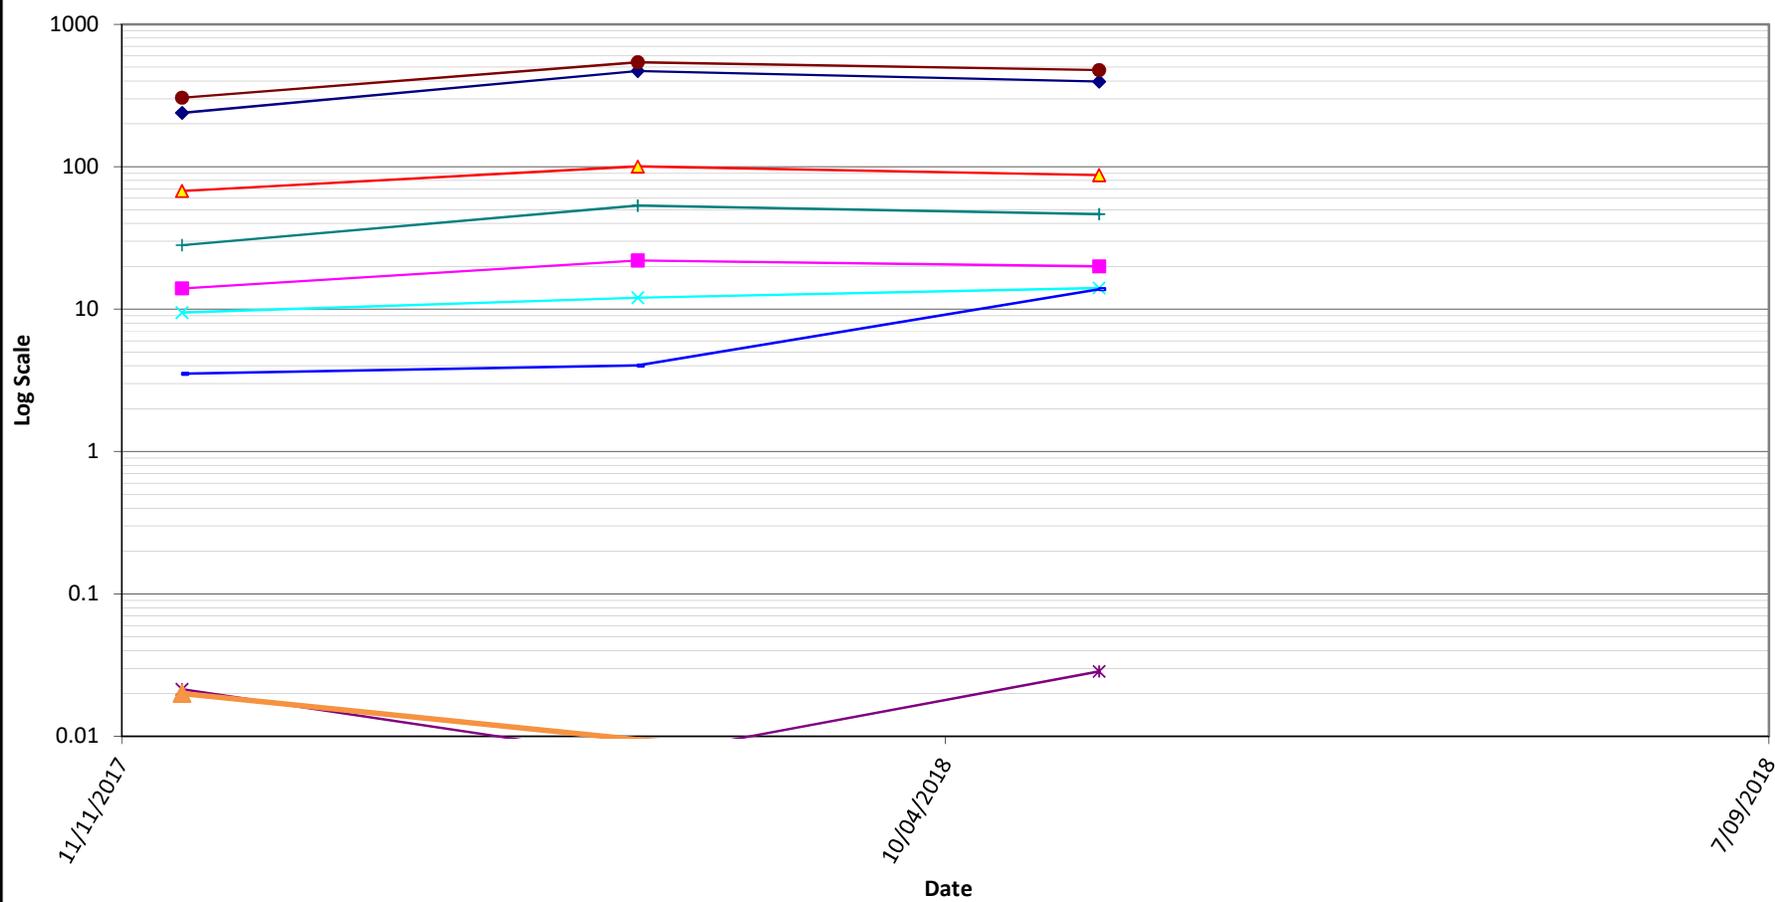
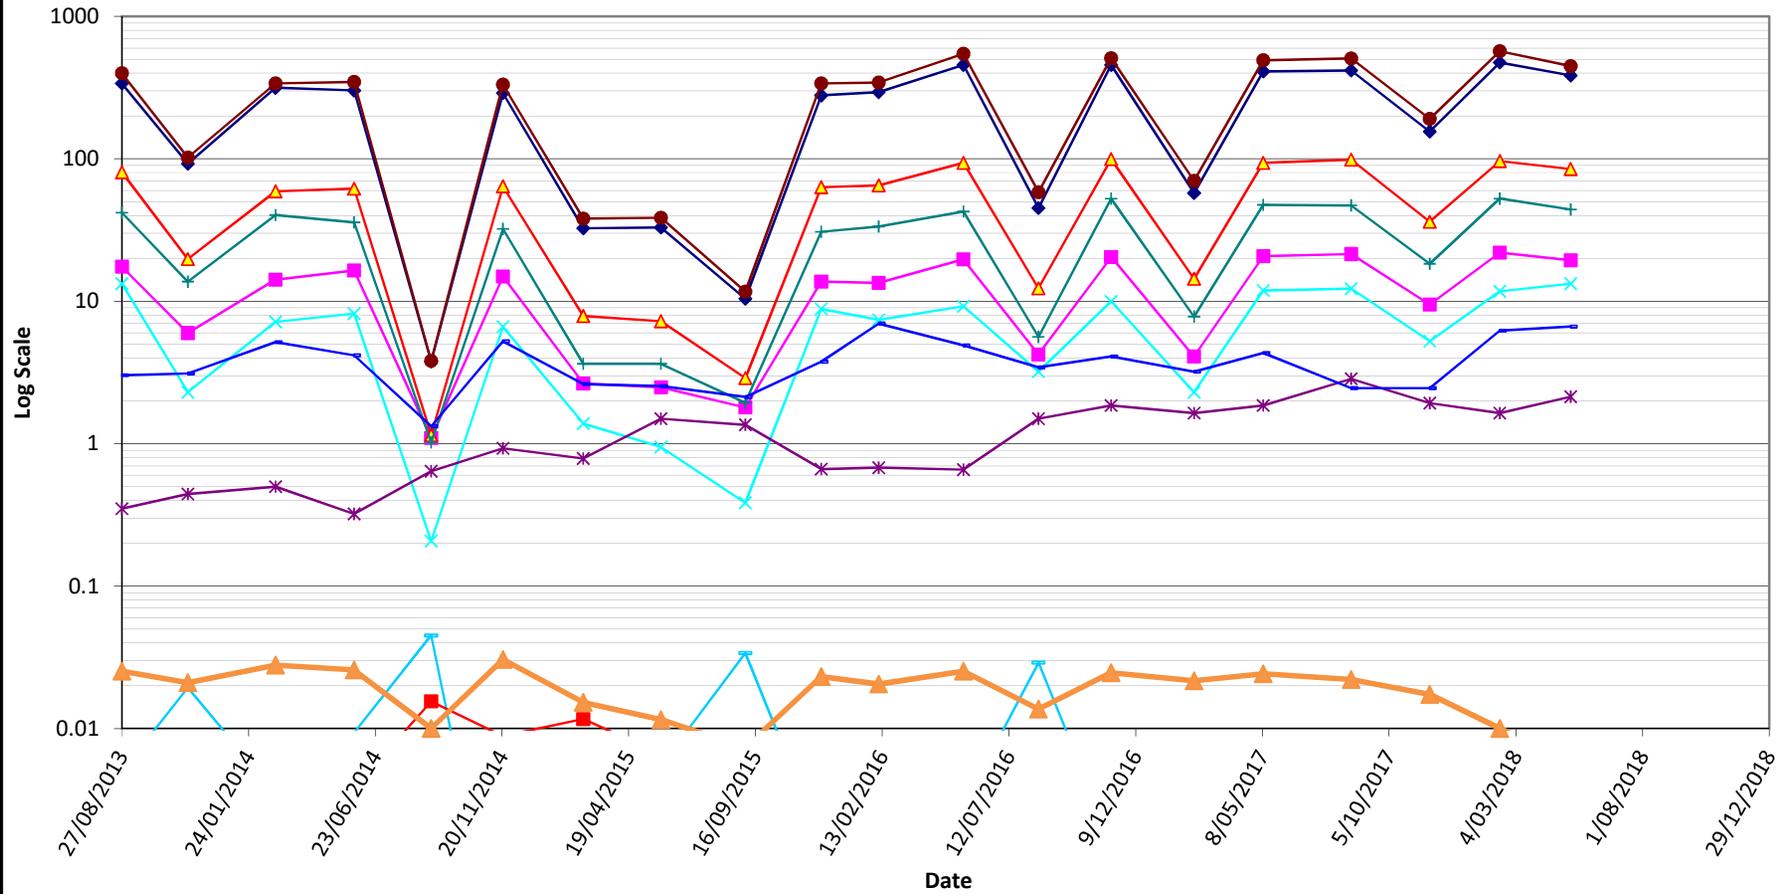
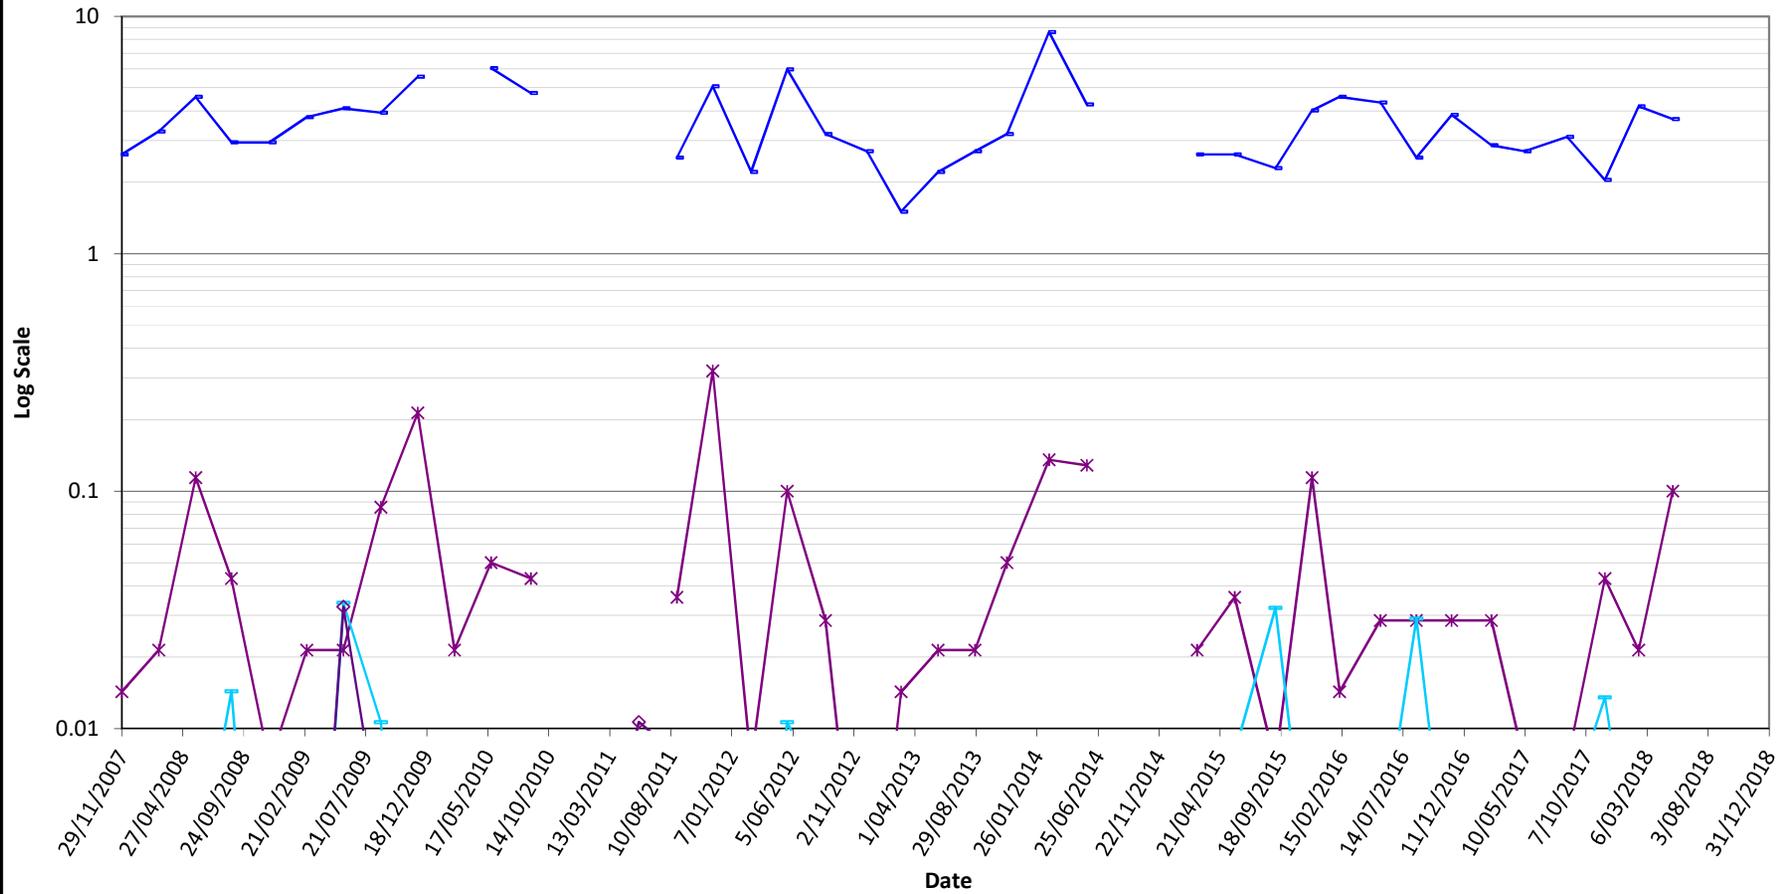
The four surface water creek sites SWC2, SWC_Up, SWC_Down and SWC_Down_2 (Figure 2) were also sampled during the May 2018 sampling event. SWC_Down_2 is still a relatively new sampling location which was established in order to detect potential leachate impacts to Rocklow Creek originated from the eastern portion of the site (Environmental Earth Sciences NSW, 2017). SWC_Up, SWC_Down and SWC_Down_2 had high concentrations of TDS (>25,000 mg/L), notably Na^+ and Cl^- (Table 2); this is due to the tidal nature of these waters and differentiates them from landfill groundwater / surface water.

The low nutrient and L/N ratios within Rocklow Creek indicated that there was no leachate impact within Rocklow Creek. All surface water creek sampling sites (SWC2, SWC_Up, SWC_Down and SWC_Down_2) had concentrations of $\text{NH}_4^+\text{-N}$ and NO_3^- below the ANZECC (2000) guidelines. All four sites will continue to be monitored to ensure leachate is not impacting upon the Rocklow Creek.

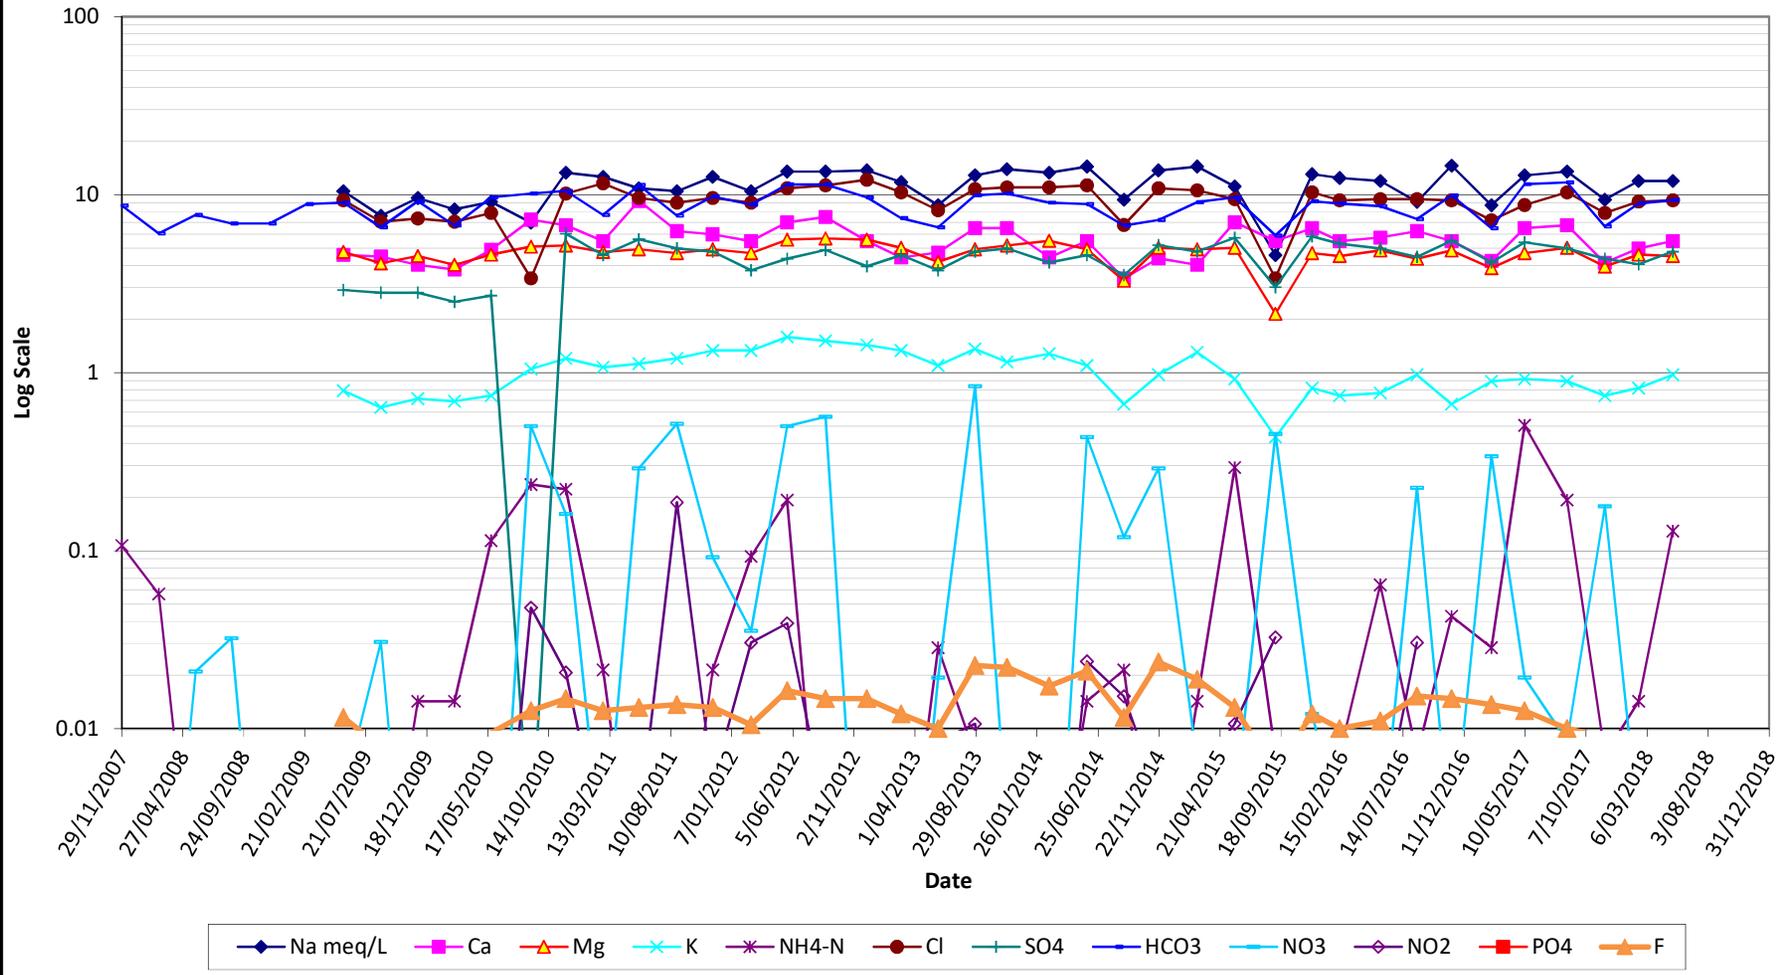
Surface water sampled at SWP2 showed little to no leachate impact. The surface water pond collects runoff from around the site and potential impacts from site activities are often observed. Ammonium concentration increased to 1.80 mg/L during this sampling round compared to February 2018 round (0.20 mg/L). Fluctuating ammonium is common at this location with previous monitoring events ranging between 0.01 and 15 mg/L. Nitrate (NO_3^-) levels (0.18 mg/L) remained below the ANZECC (2000) trigger value that was exceeded in the November 2017 monitoring round. All chemical parameters at this location are within historical ranges.

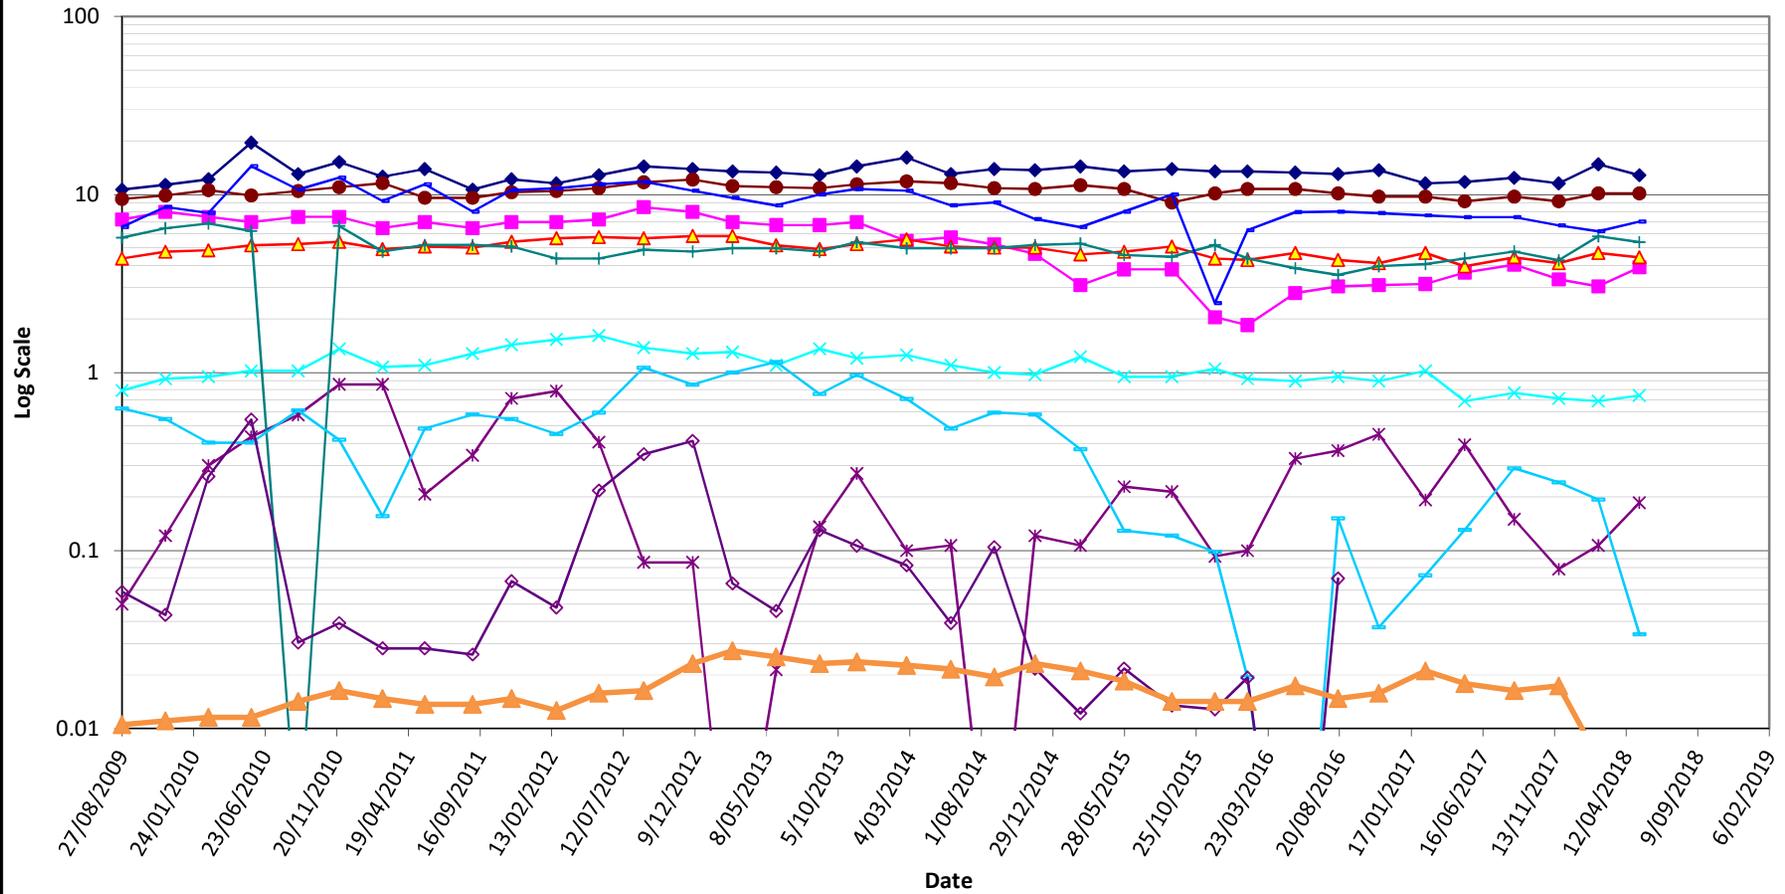
SWP4 displayed ammonium ($\text{NH}_4^+\text{-N}$) levels of 2.60 mg/L which is above the defined trigger value. Nitrate (NO_3^-) levels decreased to 2.10 mg/L which is below the trigger value established by the ANZECC (2000) guidelines. These values are indicative of the occurrence of the natural process of nitrification by which $\text{NH}_4\text{-N}$ naturally attenuates. All chemical parameters at this location are within historical ranges.
